Assessment of Contaminated Soil and Groundwater

4.1 Field observations of the current situation on land

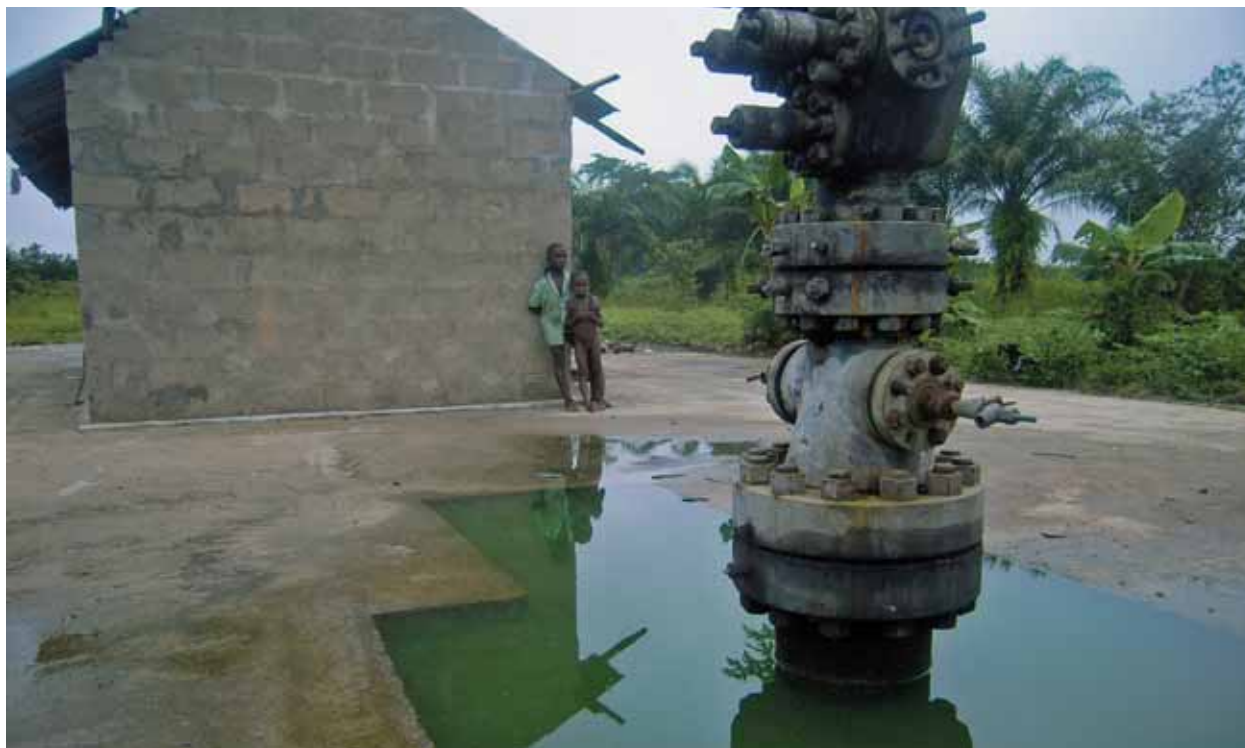
A house constructed on a well pad (Yorla 9, Khana LGA)

In at least one instance, at Yorla 9, the assessment team came across a family that had built its house within metres of the oil well, on the well pad itself. The family, with very young children, was also using the land around the well pad, within the oil well right of way, for farming. This observation is disturbing in many ways. To begin with, from a safety point of view, especially where children are concerned, it is wholly inappropriate that the family home is located so close to the wellhead. An immediate hazard is that the children may fall and drown in the (currently unprotected) well pit around the wellhead. Moreover, surrounding the well site are a number of other mud and water pits which, even if uncontaminated, are also potential hazards to both children and adults. In addition, the family is unprotected from fire, which is not unusual at disused oil wells in Ogoniland.

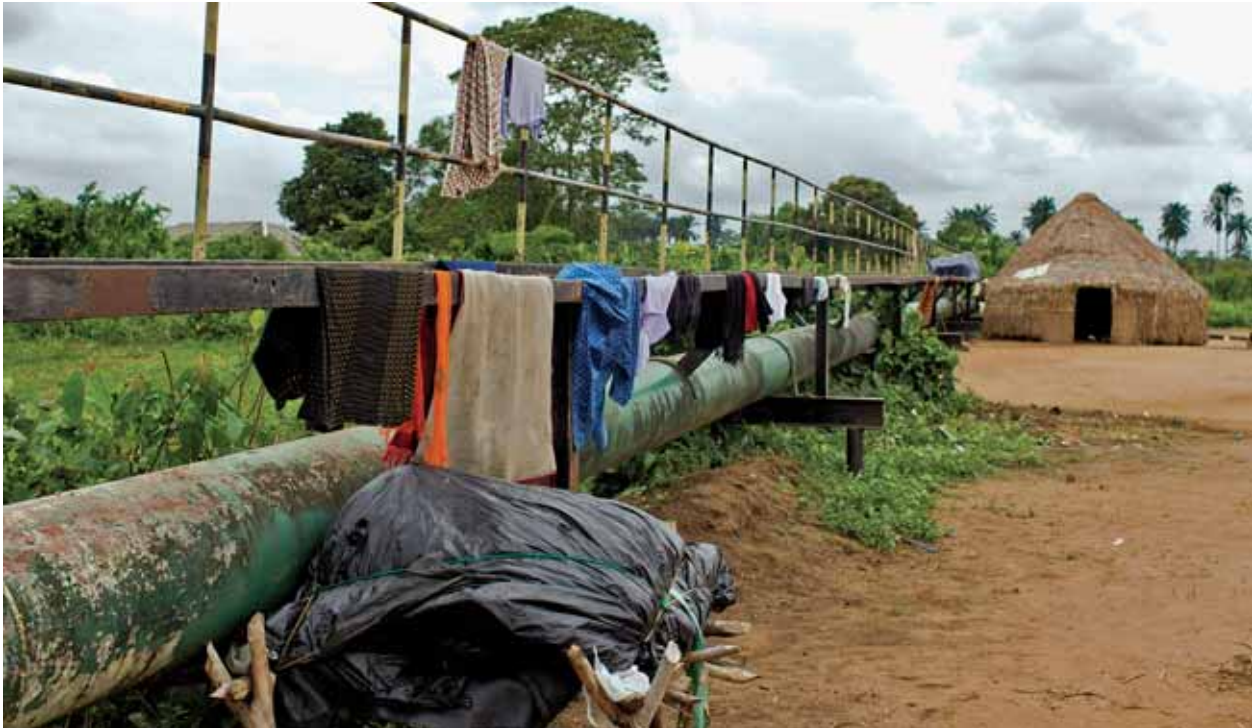
A traditional house, made from combustible material, adjacent to a pipeline (Ebubu Obolo, Eleme LGA)

In some locations the project team observed buildings very close to rights of way; indeed in extreme cases the right of way itself had ceased to exist owing to the construction of farms and houses along it. An entire village of the Hausa community, for instance, lies along what appears to be a flare pipeline next to a flow station. Furthermore, the Hausa houses are made of readily combustible materials.

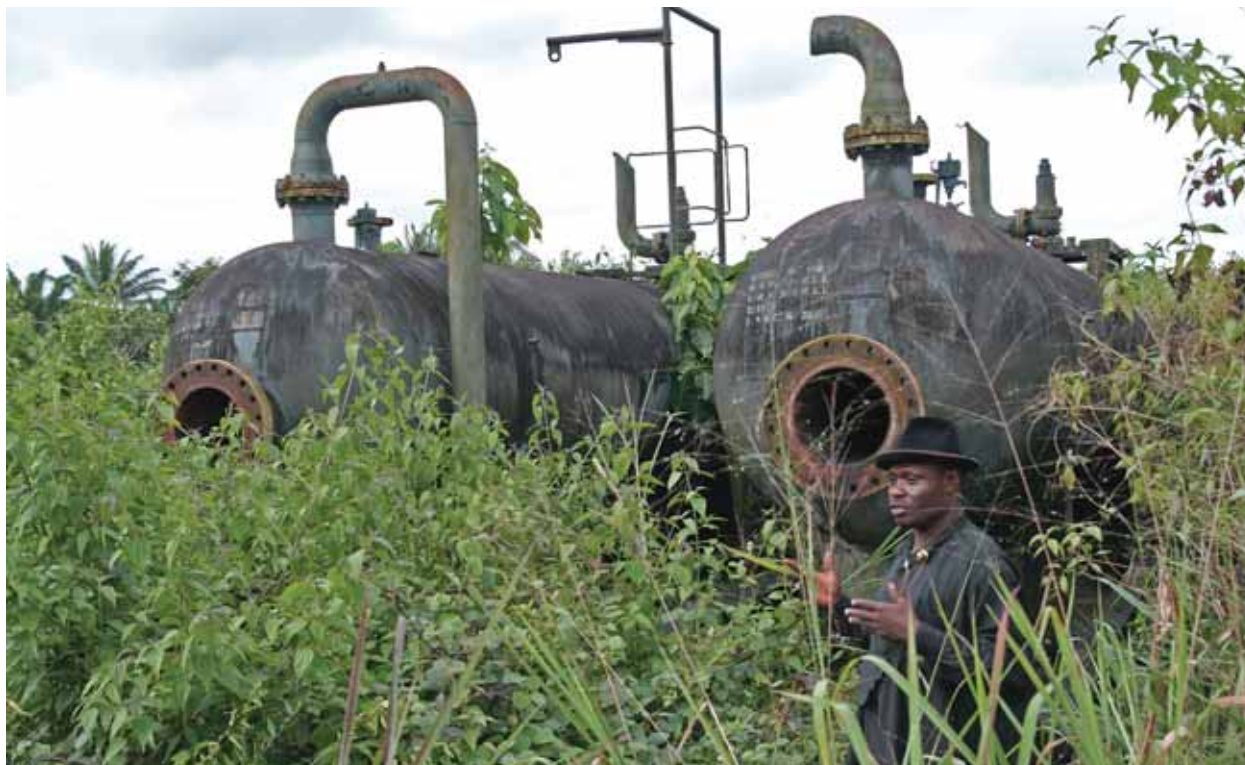
Chief Vincent Kamanu at part of an SPDC facility overgrown with vegetation (Gio, Tai LGA)

The project team observed overgrown wellheads and pipeline rights of way at several sites. In some cases, excessive vegetation growth prevented access by the UNEP team.

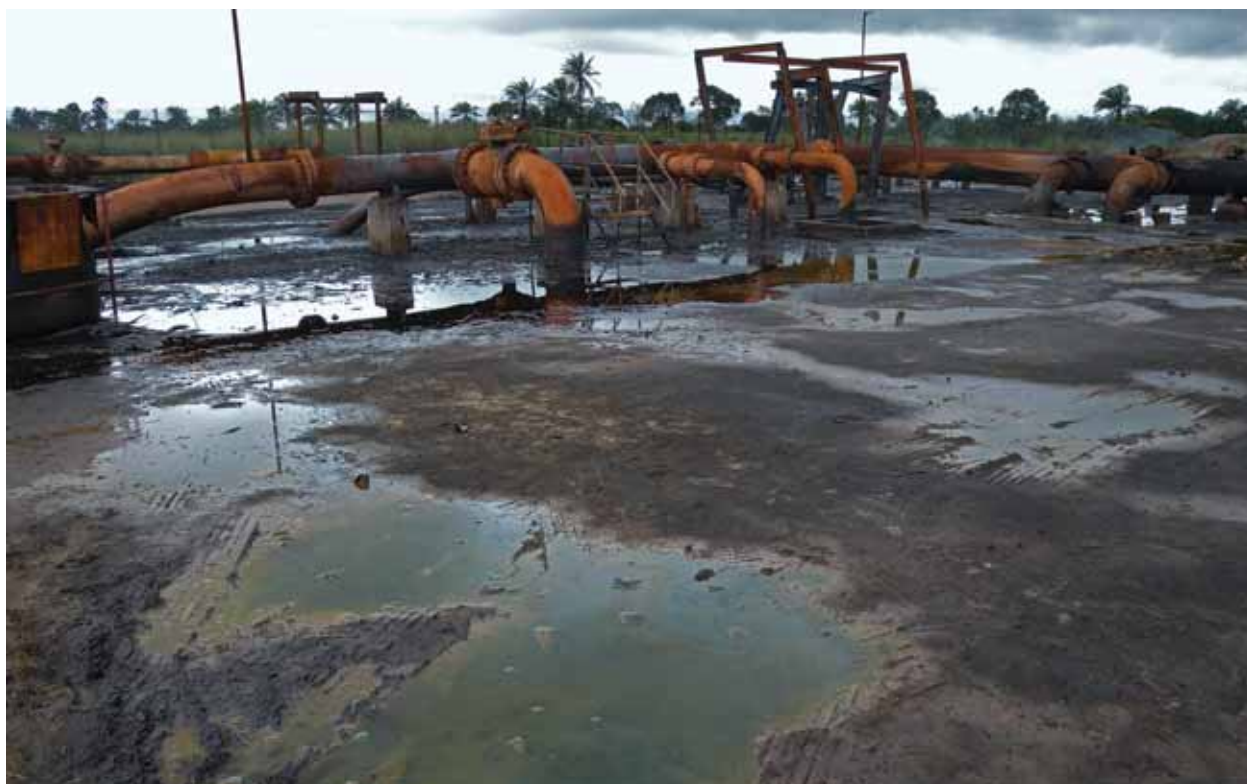
Visits to a number of facilities confirmed this understanding. Most alarming was the situation at Bomu flow station in K-Dere. When the UNEP team first visited this location, the fences (since fixed) were broken and oil contamination was visible within the site. Given that the area around this facility is densely populated, this is a very serious situation from the point of view of both community safety and security of the facility.

A view of the Bomu flow station (K-Dere, Gokana LGA)

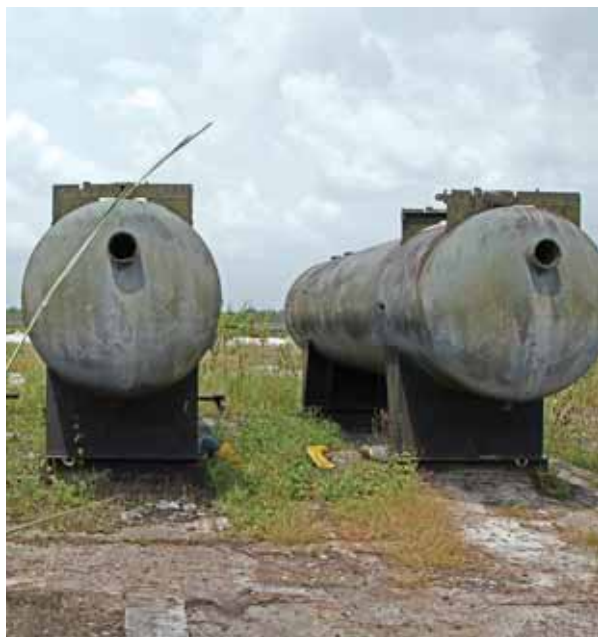
*Abandoned oil field infrastructure
(Bodo West, Bonny LGA)*

The abandoned facilities in Ogoniland pose both environmental and safety risks. From an environmental point of view, there is no indication as to whether the various containers lying around are full or empty, or what they contain(ed). Corrosion of metallic objects leads to ground contamination by heavy metals. Attempts by criminal elements to recover objects for sale as scrap may lead to safety risks, both on and off oilfield sites, while children playing on these facilities also face health risks.

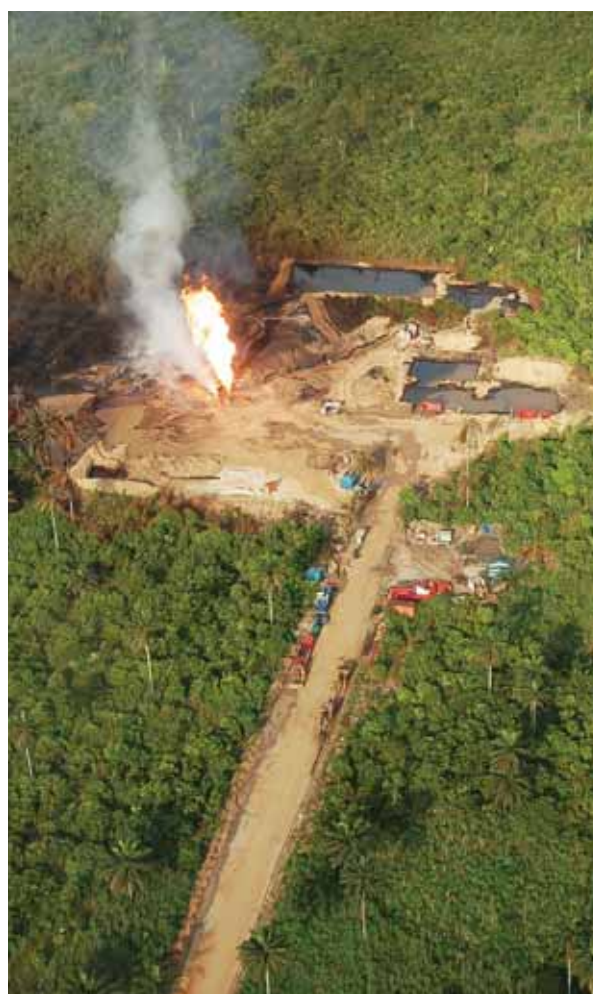
massive fire was raging at the Yorla 13 oil well and apparently continued burning for over a month. Such fires cause damage to the vegetation immediately around the well site and can produce partly burned hydrocarbons that may be carried for considerable distances before falling on farmland or housing.

An oil well on fire (Yorla 13, Khana LGA)

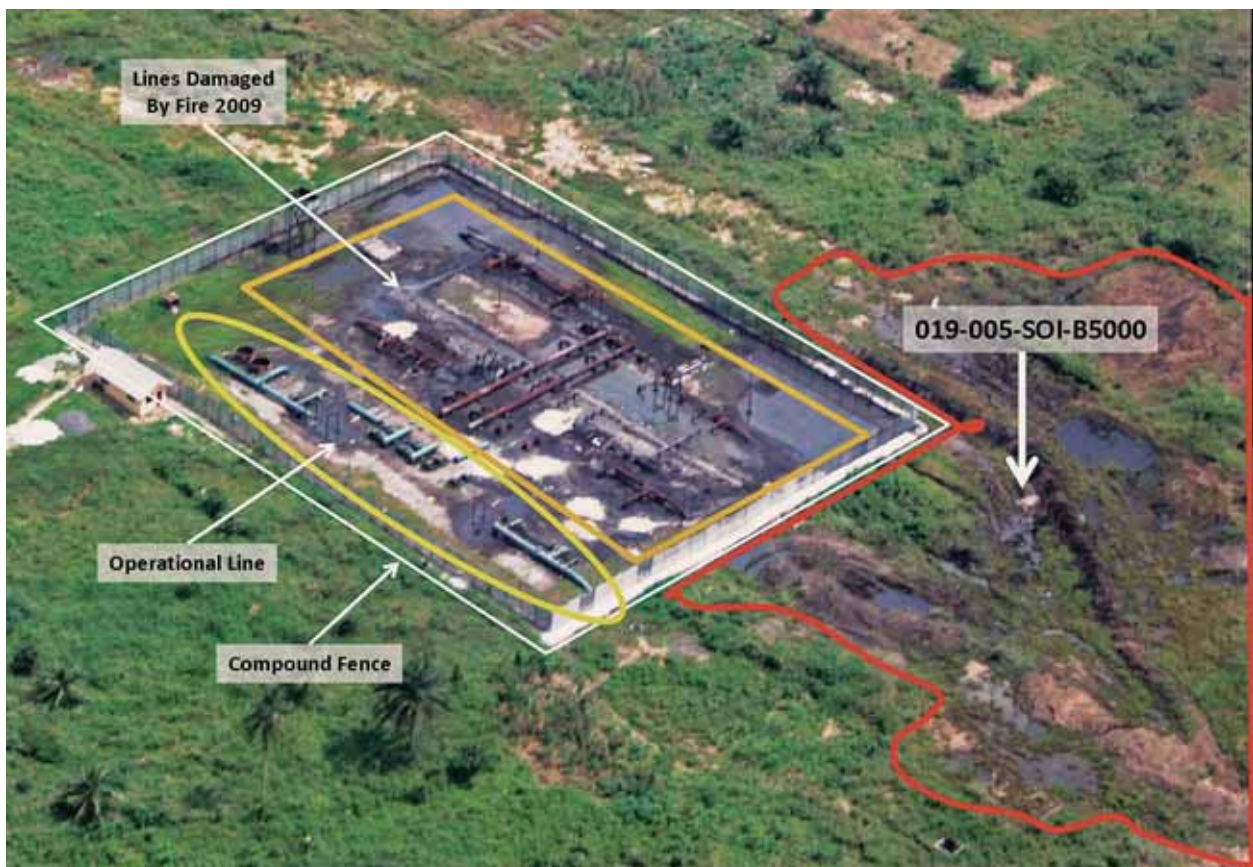
Aerial view of the Bomu manifold (K-Dere, Gokana LGA)

Visual observations on site. Most of the manifold area inside the fence is covered in oily residues, soot and ash. Oil is seeping from the concrete seal through the fence into the surrounding area. The extent of the contamination covers the manifold area itself and an additional 19,000 square metres of land outside the manifold. Of this, some 9,000 square metres are heavily polluted, the concentration of oil on the surface being above saturation, resulting in an oily sheen on pools of standing water and a strong oily smell. Some of the still operational pipes are leaking and the oil collected from them is stored in an open container with a volume of approximately 10 cubic metres.

A small trench leading south from the manifold is heavily contaminated with oil. It leads into a small collection pond covering an area of approximately 600 square metres adjacent to the abandoned house south of the manifold, before continuing to connect with a small creek that flows south towards Bodo. Next to the abandoned house the sampling team found an open, hand-dug well in which the groundwater was approximately 1 metre below surface level, the same level as groundwater found in the monitoring wells on the site.

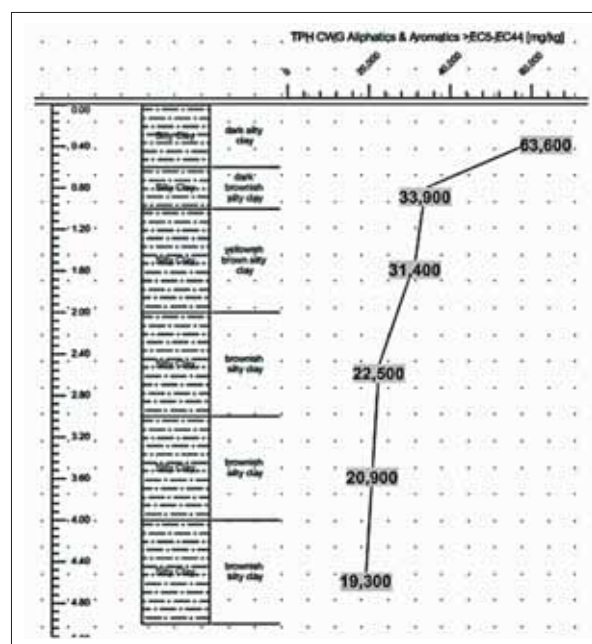
Figure 10. Vertical profile of contamination at 019-005-SOI-B5000

The highest soil contaminations, at 63,600 mg/kg TPH, were found in the top 0.60 metres of a borehole in the most heavily contaminated area directly bordering the southernmost part of the manifold (019-005-SOI-B5000). This is extremely high and is far above the EGASPIN intervention value of 5,000 mg/kg. Contamination gradually decreased with depth until at 4-5 metres below ground surface (bgs) concentrations fell below 20,000 mg/kg (Figure 10).

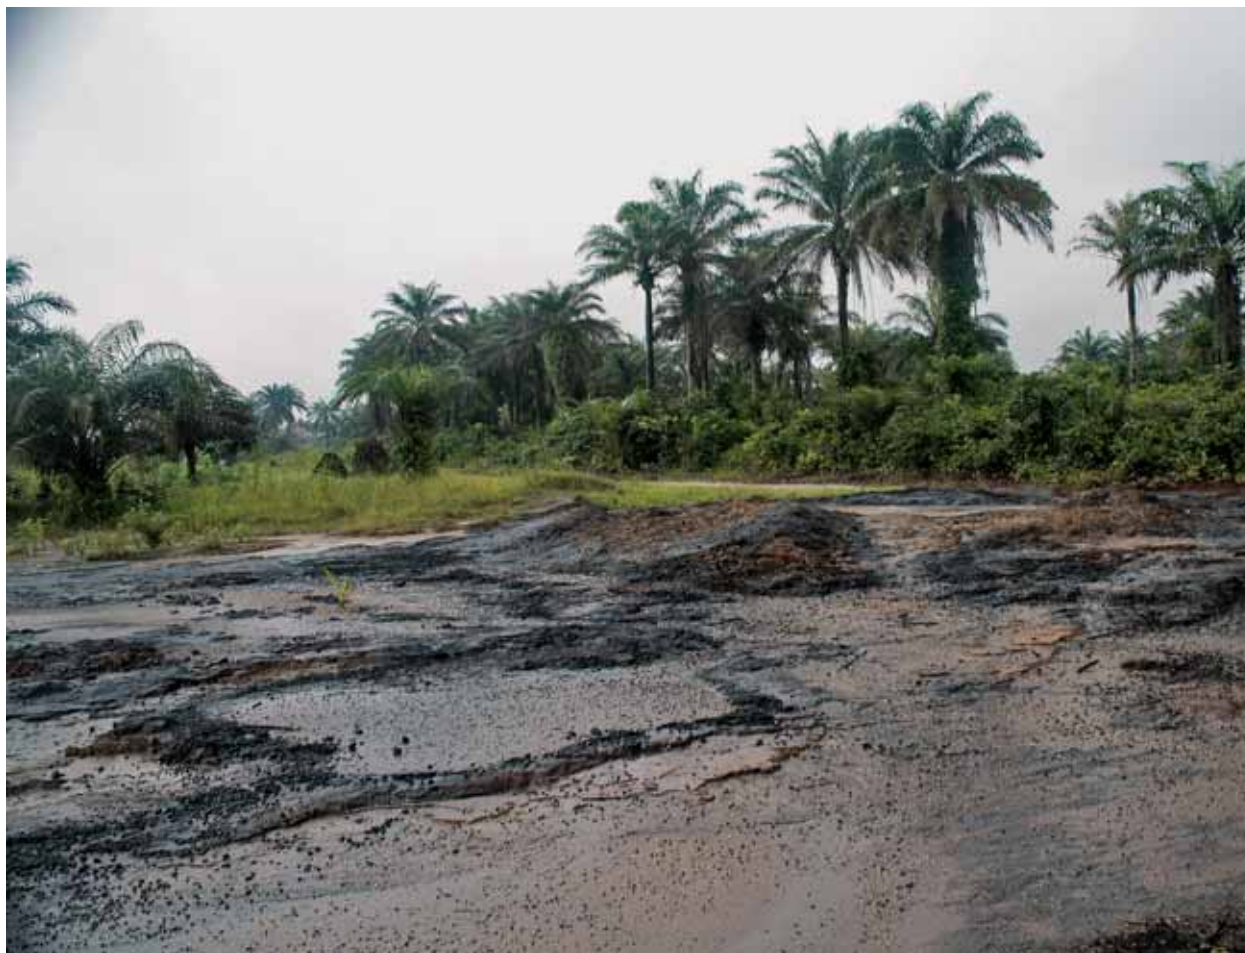
The contamination in the immediate vicinity of the spill was never remediated, as suggested by the soil sampling results.

NNPC trunk line spill (K-Dere, Gokana LGA)

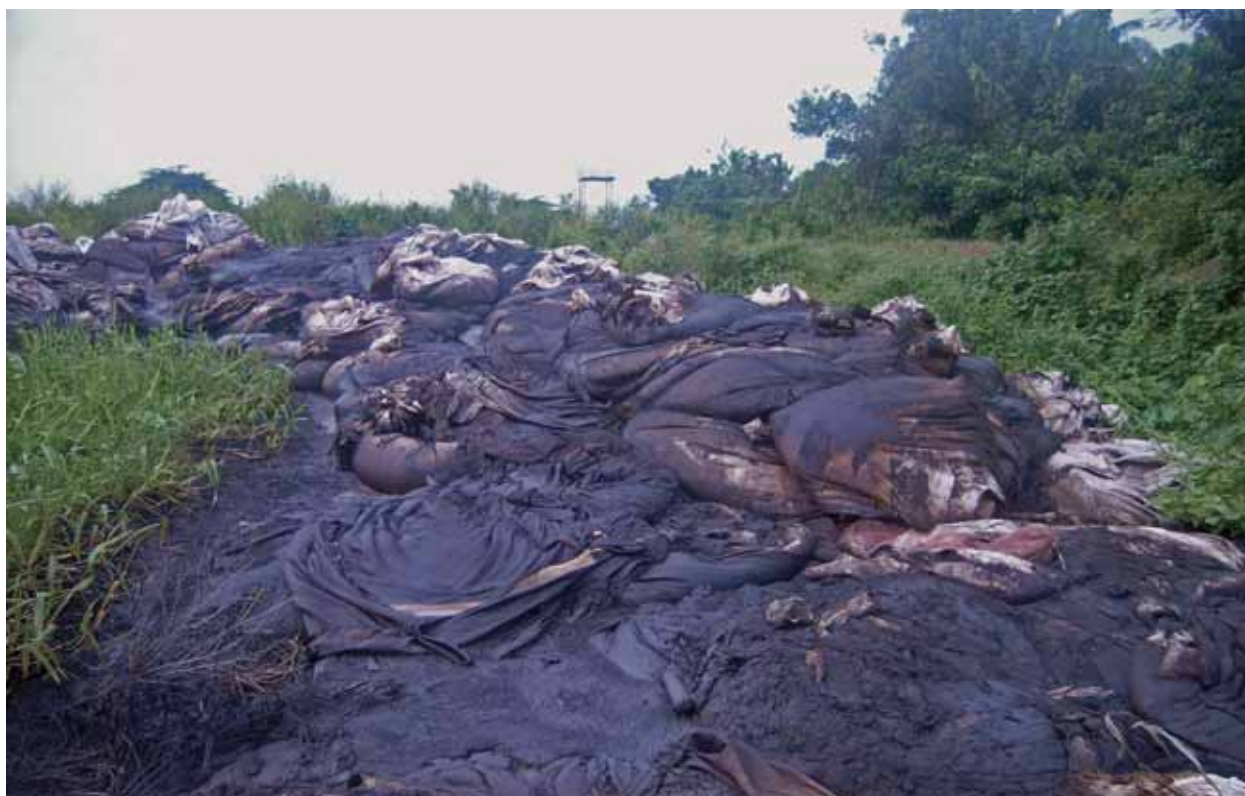
Some of the bags were broken and oil had already leached into the soil. Most of the 31 soil samples collected from around the waste were only slightly contaminated, with TPH concentrations below 500 mg/kg in 28 samples and below 50 mg/kg in 10 samples. Some of the samples had elevated levels of barium (maximum 2,630 mg/kg), which raises the possibility that the waste may have come from drilling operations (in which barium is used as a weighting agent).

Fly tipping of oilfield waste in Ogoniland (Oken Oyaa, Eleme LGA)

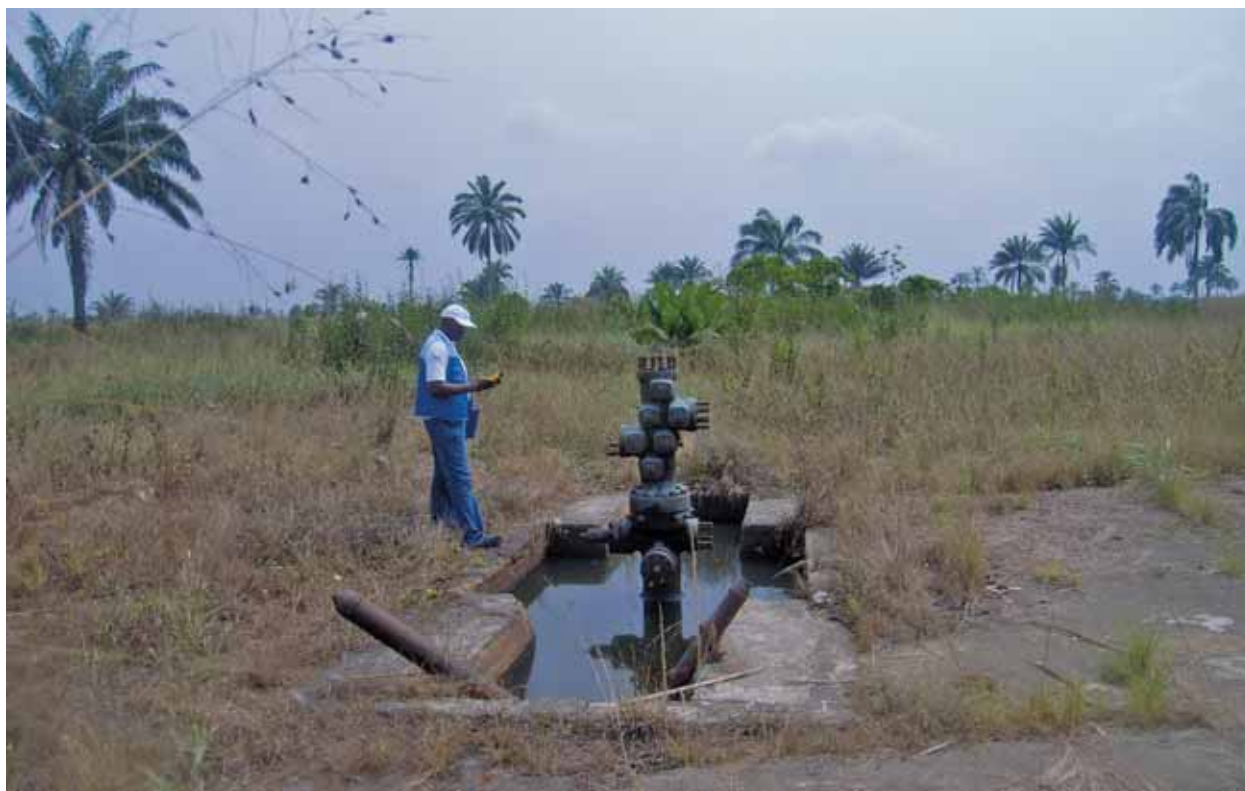
The former tailings pit was easily identifiable as a rectangular, shallow, dry depression in the ground next to the wellhead. Sampling revealed that oil-based muds had been used for drilling. Except for the tailings pits, all the soil profiles on the site revealed soil in natural bedding, indicating that the SPDC remediation attempt had consisted of enhanced natural attenuation.

Korokoro Well 3 (Tai, LGA)

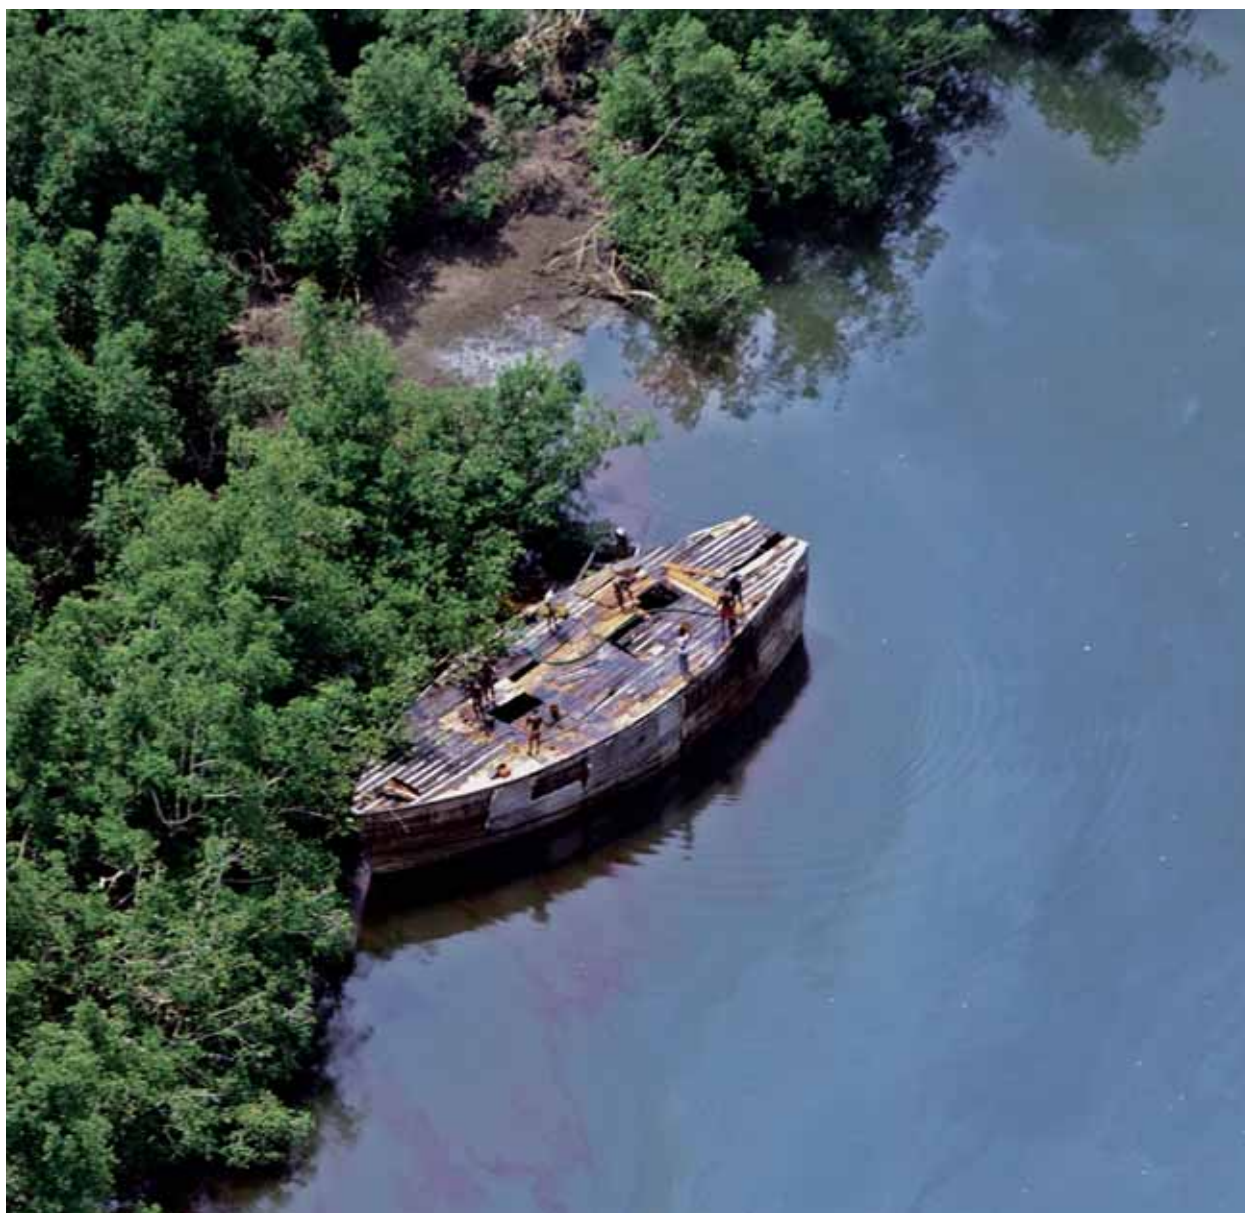
Visible hydrocarbon pollution on surface water and vessel used to transport oil

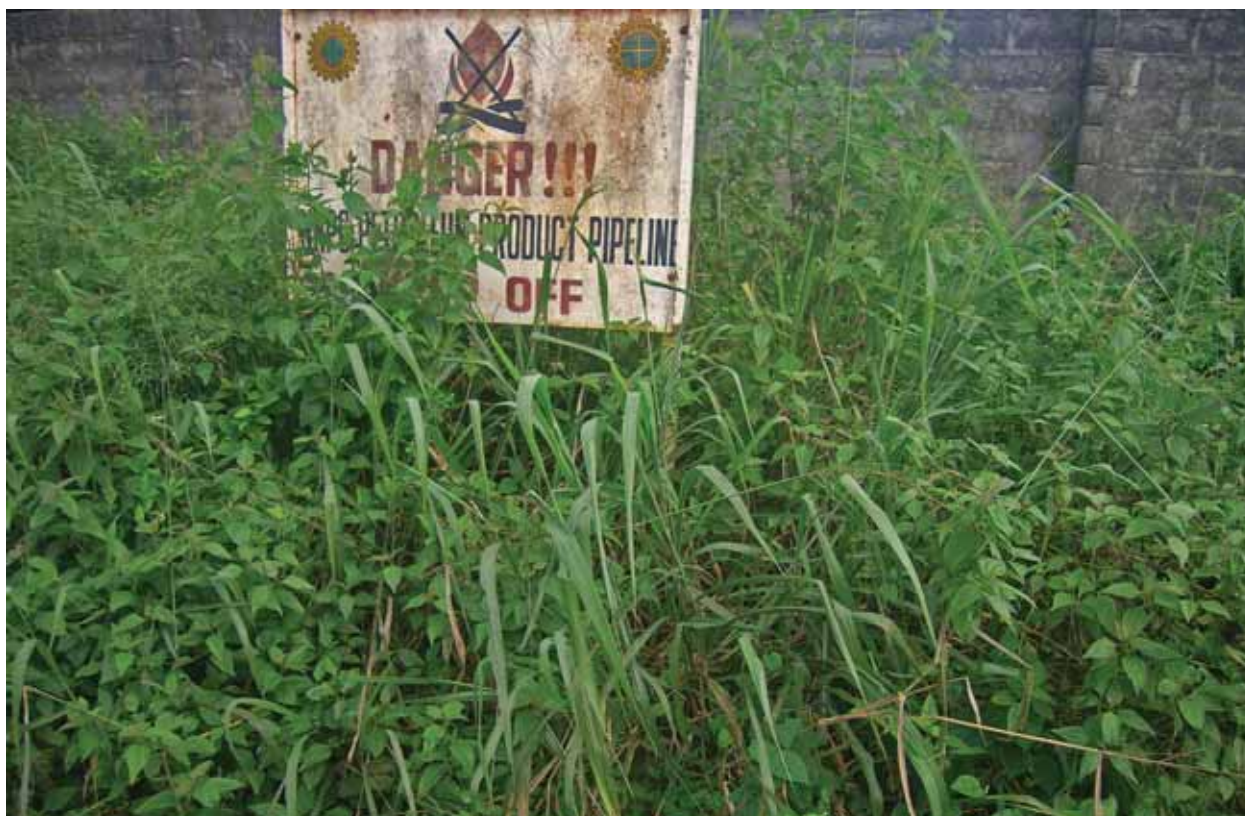
Undergrowth shrouds a warning sign at Ogale, Eleme LGA

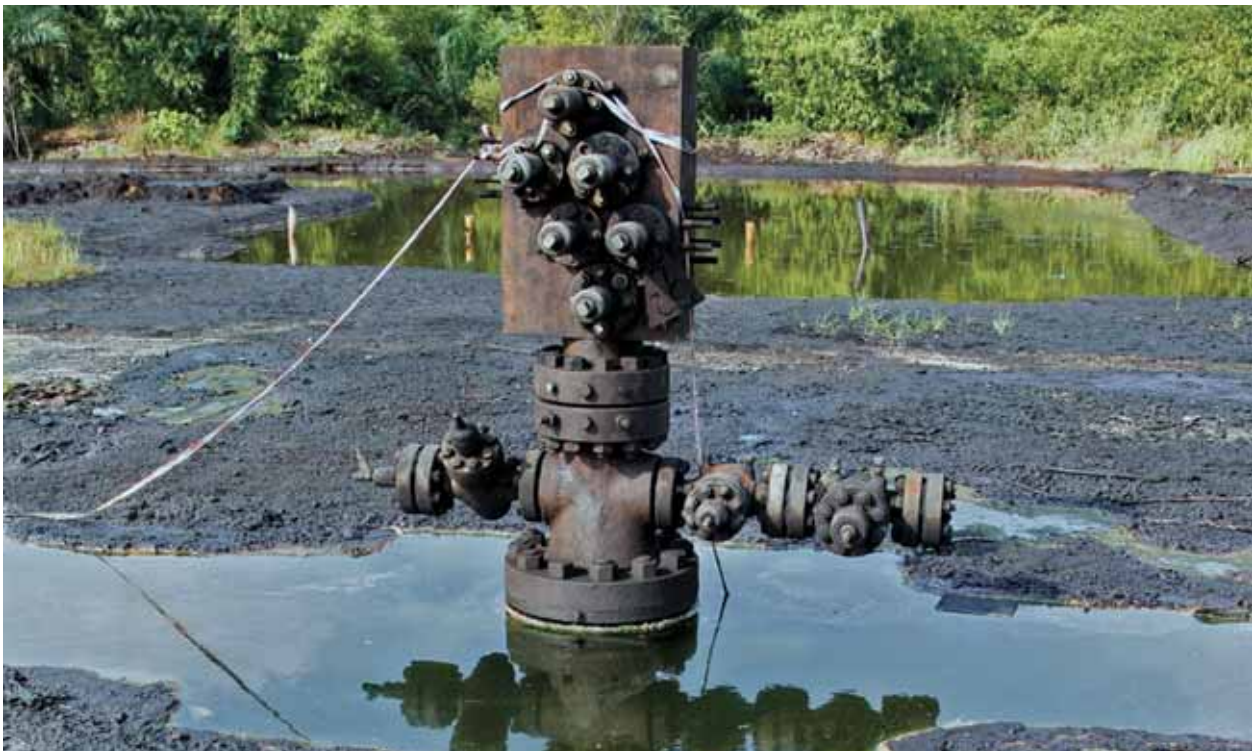
Easily accessible disused wellhead (Bomu 27, Gokana LGA)

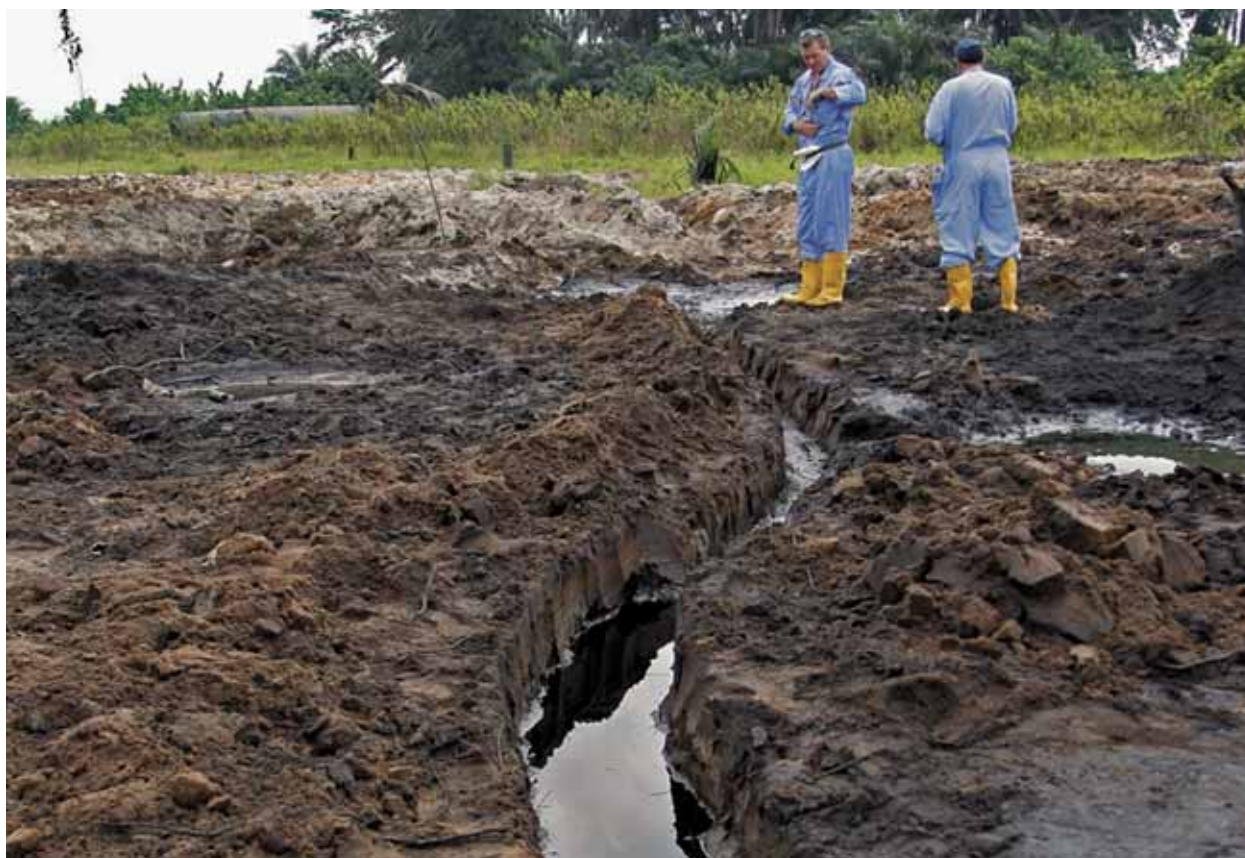
*A trench made from a RENA site to a nearby watercourse (Bodo West, Bonny LGA).
The fluid in the channel is degraded crude oil*
