STORACIE AND RIGH

MSc Ing. Claudia Cabal

8th November 2016

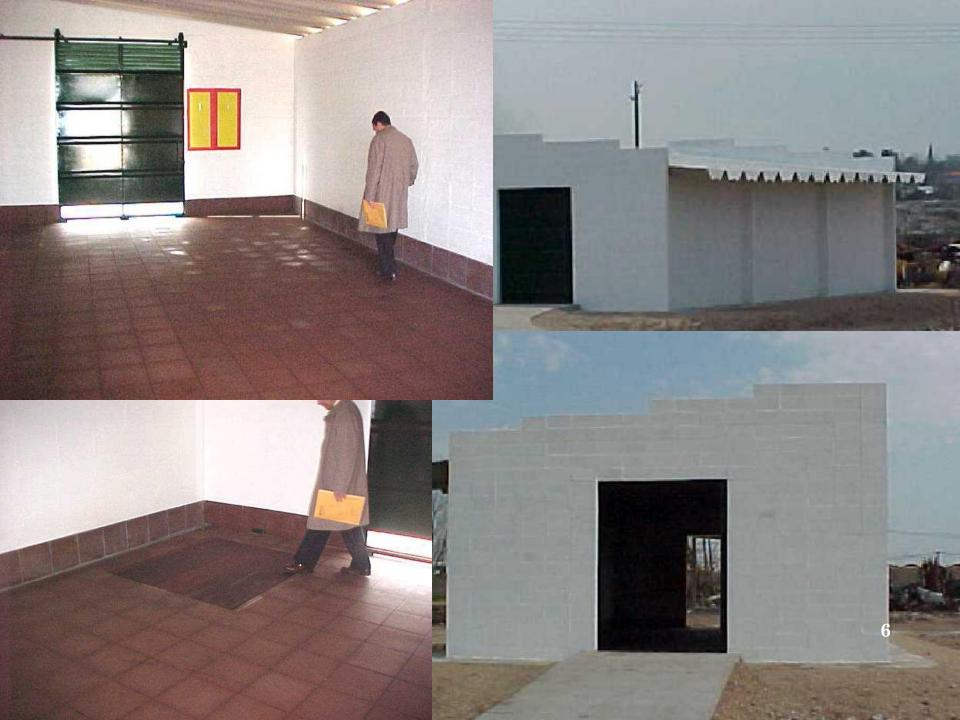
IN EVALUATING A STORAGE FACILITY THE FOLLOWING ASPECTS MUST BE CONSIDER

- Does the facility have adequate roof and walls to prevent rain water from reaching the stored PCBs?
- Is the containment volume sufficient for quantity of PCBs stored?
- Is the containment area free of drains, valves, joints, or other openings?
- Are flooring and curbing requirements met?
- Is the site above the 100-year flood elevation?

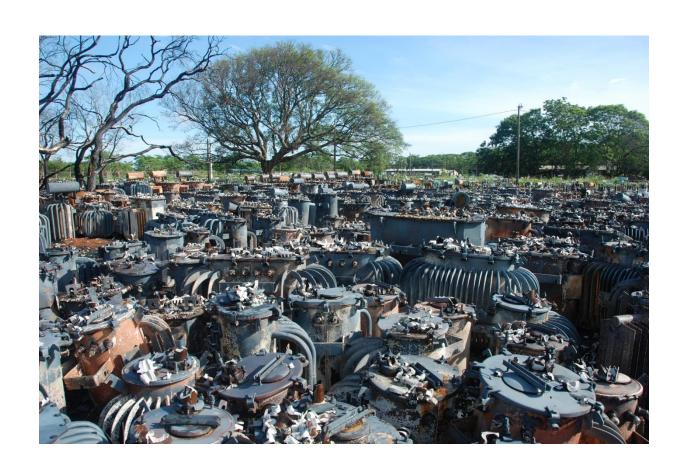
IMPROPER STORAGE

Open area exposed to rainwater

Outdated inventories

Storage

Floor without barriers to percolation

Equipment not sampled

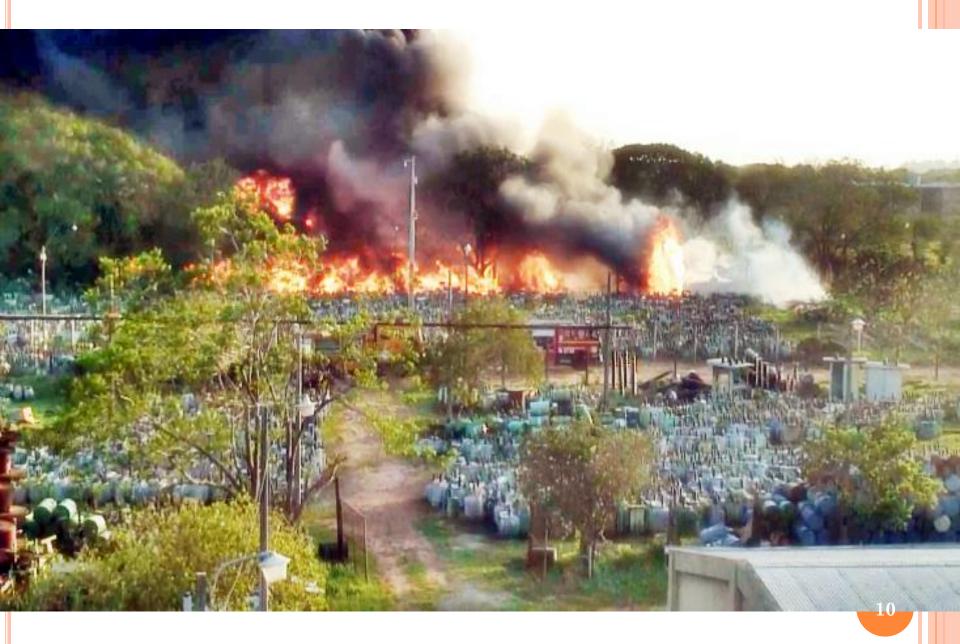
- The fire took place on 14th October 2015 in a transformer storage located in a densely populated metropolitan area 11 km from the capital Asuncion.
- The site covered approximately 27 hectares and has 20,000 transformers. The fire affected approximately 6,000.
- Equipment including stored transformers, capacitors, and other materials that may contain PCB, which can generate a large amount of dioxins and furans, were affected by the blaze.

- On 23rd October 2015 the Executive Secretary of the Paraguay Ministry of Environment officially requested the United Nations Environment Programme (UNEP) and the Secretariat of the Basel, Rotterdam and Stockholm (BRS) Conventions for technical assistance and guidance to assess the impact of the event and to appropriately deal with the resulting waste.
- A team was assembled, and the mission took place $9^{th} 22^{nd}$ November 2015.

- The objective of the mission was to evaluate the extent of the environmental risk to the fireaffected sites, including the associated runoff, leaks, spills and waste, and provide recommendations for the management of the waste resulting from the incident.
- The objectives also included assessing the extent of human health risks at the fire-affected sites and provide guidance for reducing future risks. The evaluations and assessments by the team included interviews, aerial photography, and other assessment techniques used to evaluate the situation and develop recommendations.
