# Lebanon

## Post-Conflict Environmental Assessment

United Nations Environment Programme

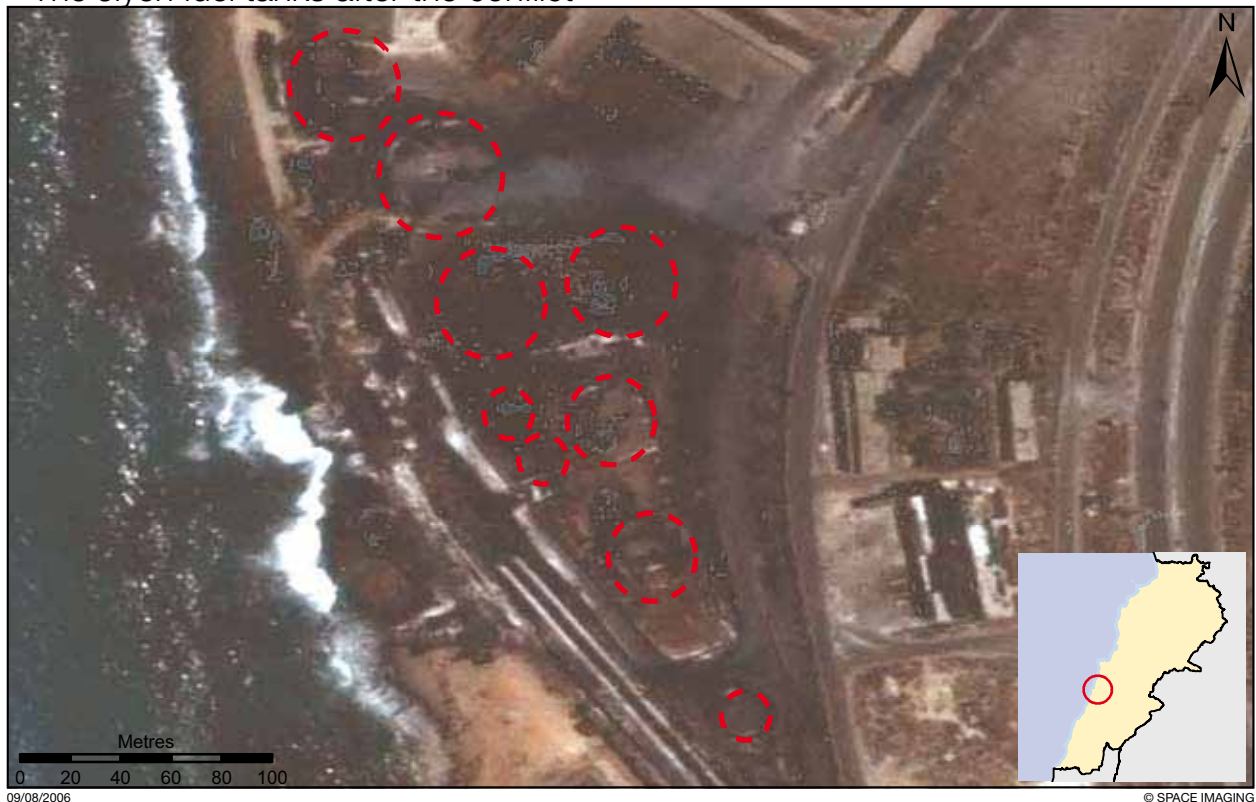
The Jiyeh fuel tanks after the conflict

The site management reported that two of the larger tanks were directly hit during the bombing of the site on 13 and 15 July, and that fire engulfed and largely destroyed the remaining tanks. Consequently, only the small underground tank was still intact at the time of inspection.

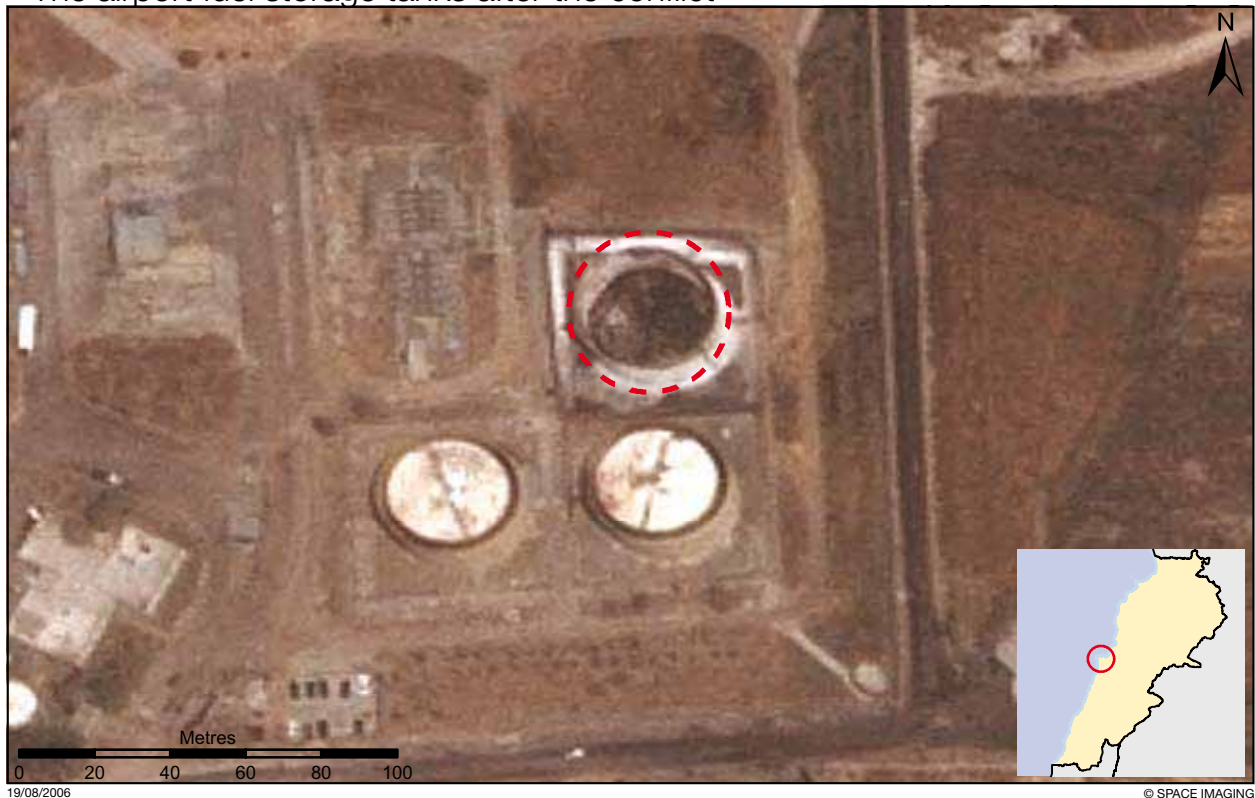
The airport fuel storage tanks after the conflict

Both soil samples emitted a strong smell of kerosene, leading to the conclusion that a significant amount of the fuel had leaked into the ground following the attack on the tank. The soil samples, however, showed less contamination than expected. The sample from the wall of the impounding basin showed concentrations of extractable petroleum hydrocarbons (EPH) and polycyclic aromatic hydrocarbons (PAH) below Dutch Intervention Values, while intervention values for hydrocarbons were exceeded only slightly in the sample taken from below ground surface.

site by tipper-trucks. The complete absence of health and safety equipment for the individuals participating in these activities is a matter of concern.

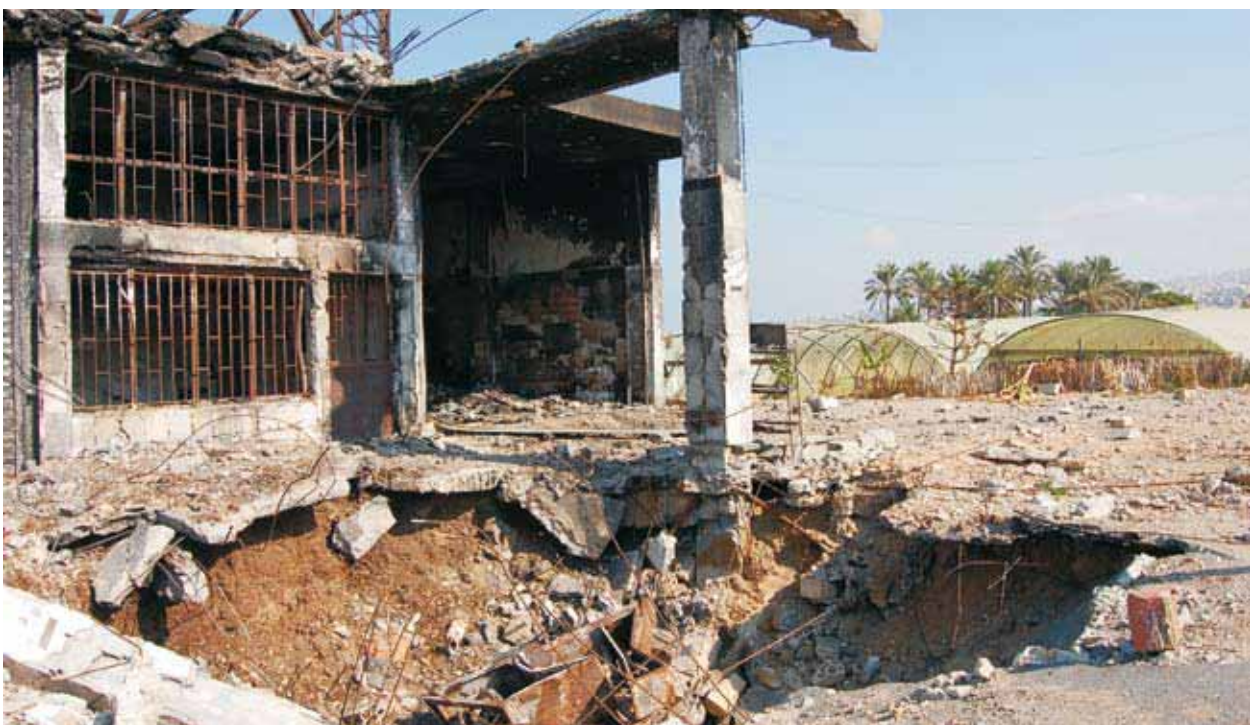
*The severely damaged Saida fuel station with bomb crater in the foreground*

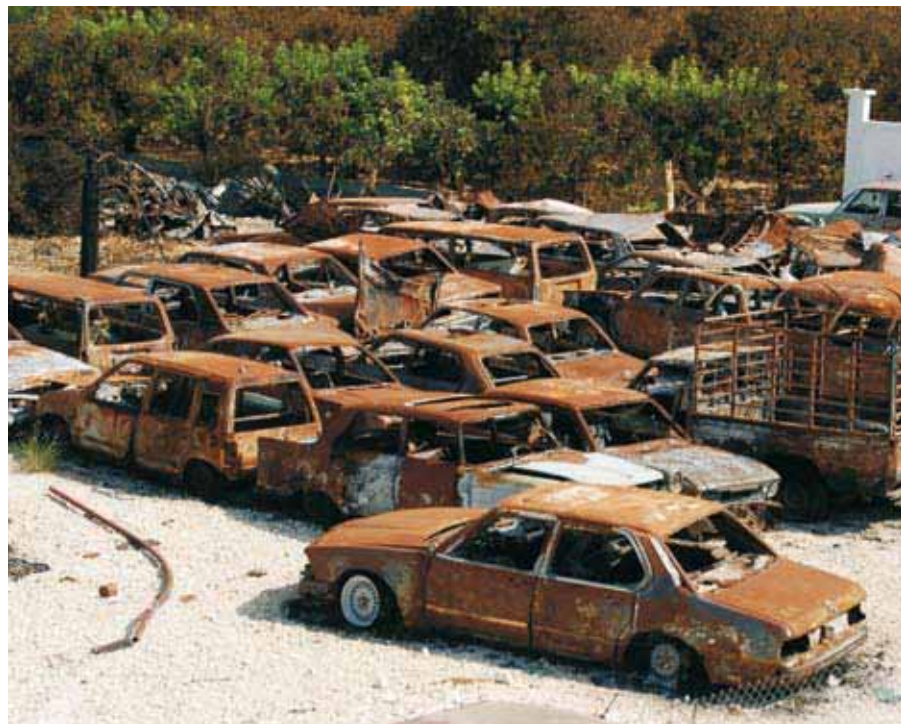
*Cars damaged in the explosion of the gas refill station*

1. The possibility of recycling the metal from the derelict vehicles should be explored. If it is not a viable option, the vehicle shells should be removed from the site, and taken to a sanitary landfill for disposal.
2. The thin layer of ash should be collected, placed inside secure re-sealable drums, and transported to a sanitary landfill site for disposal, as rain may cause leachate to migrate towards the groundwater. Due to the potentially hazardous nature of the ash, personnel involved in the clean-up activities should be provided with appropriate health and safety equipment, in particular breathing masks.

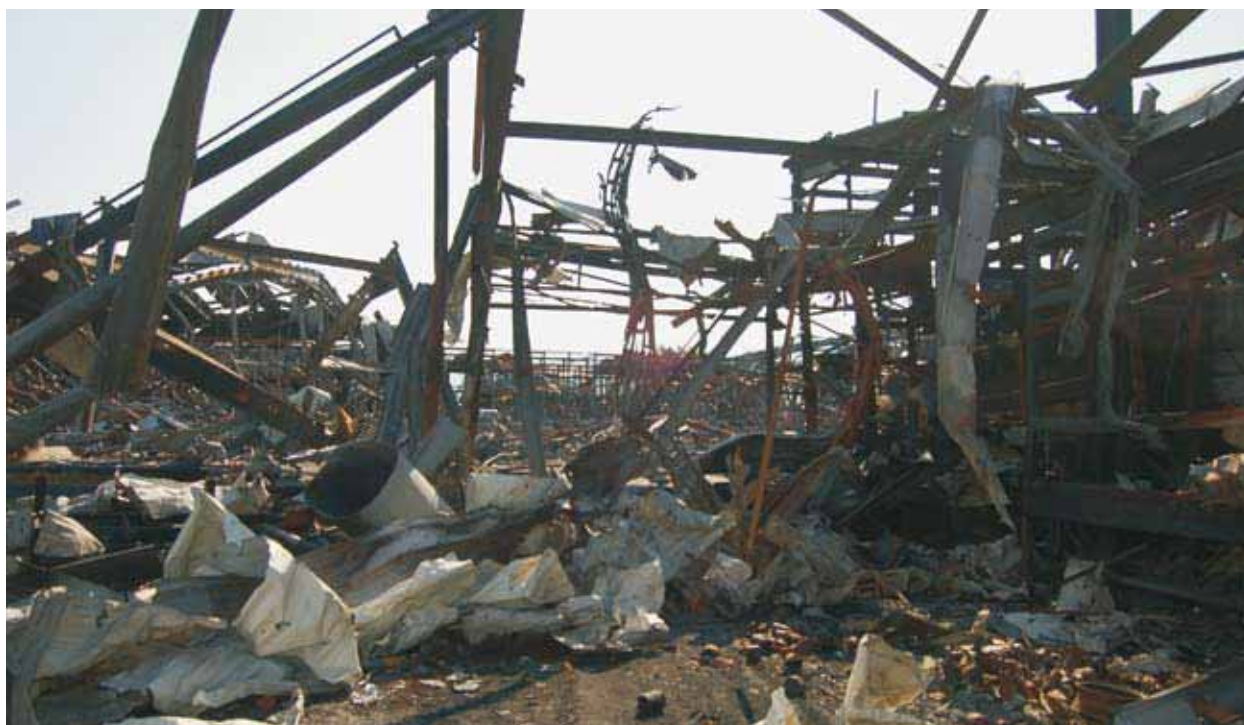
*The Transmed facility was extensively damaged during the conflict*

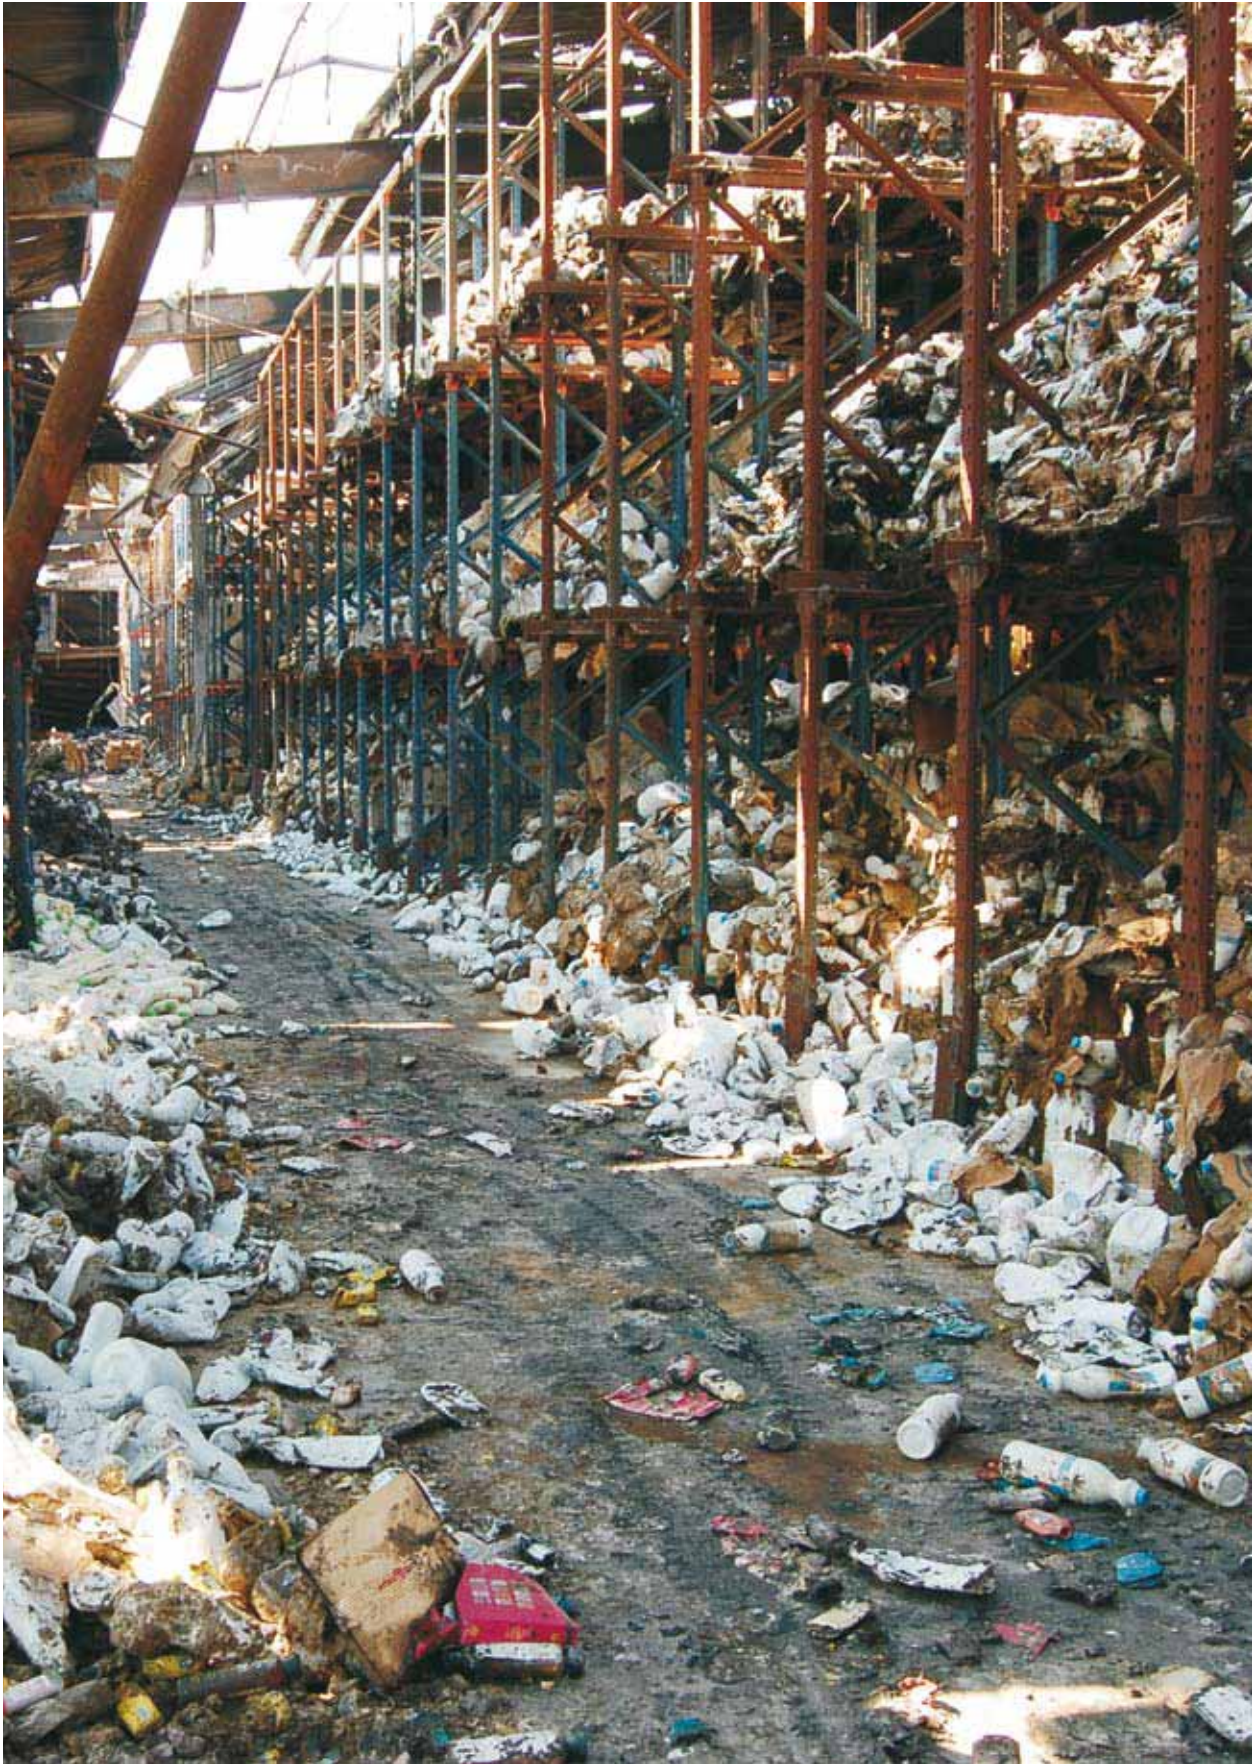
*The interior of the damaged Transmed facility*

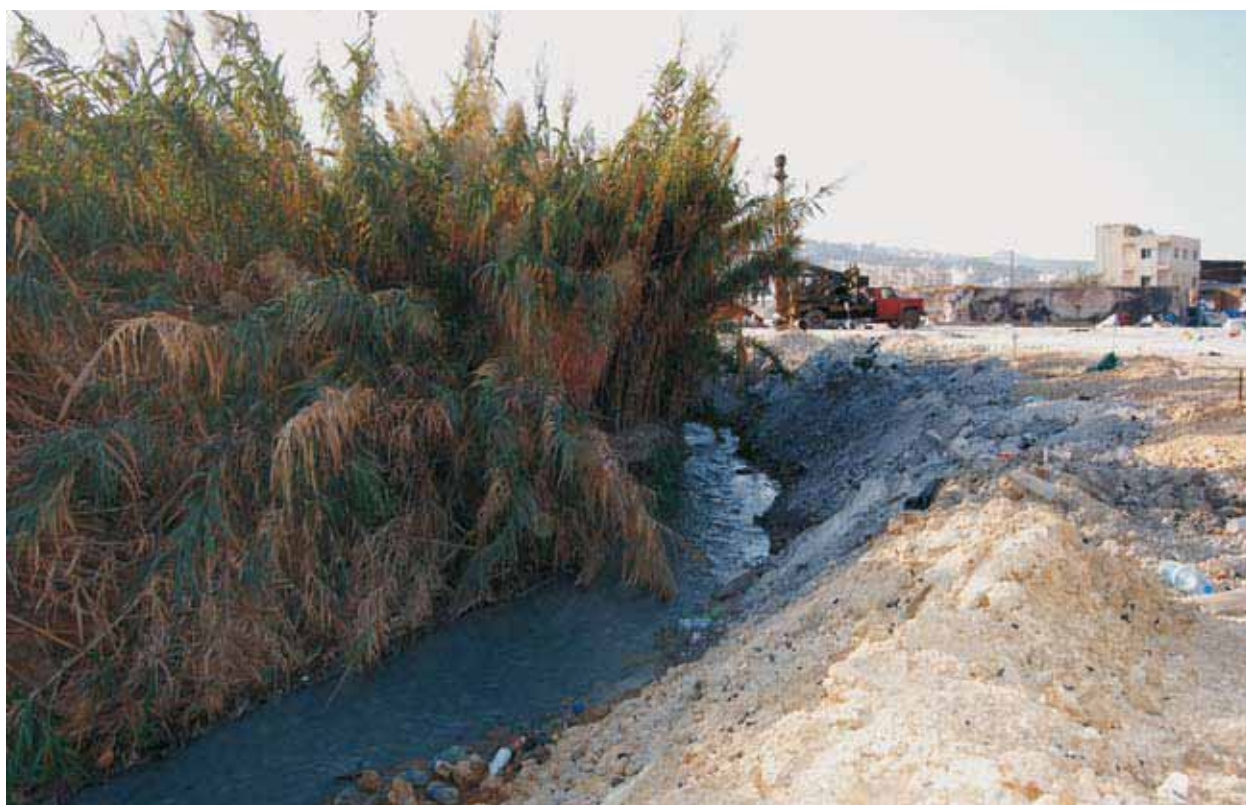
Ash from the burnt plastic goods stockpiled beside the Ghadir River

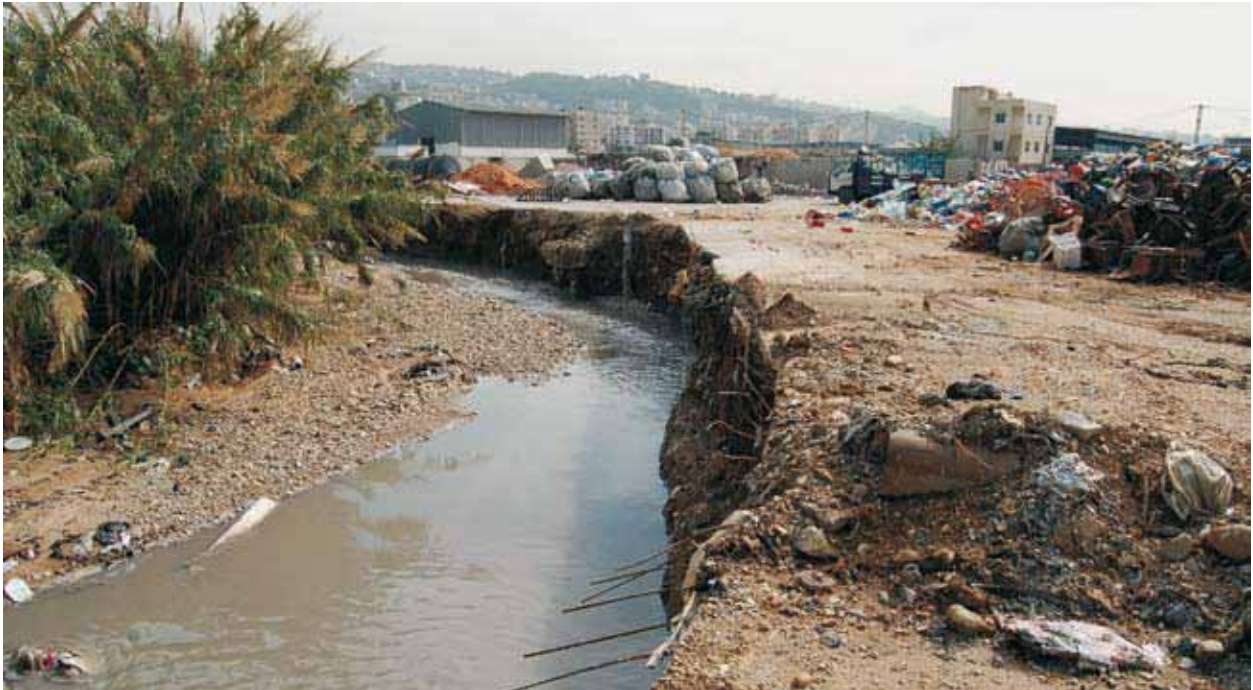
*During a follow-up visit all the ash (see photo on the previous page) had been washed away following heavy rainfall*

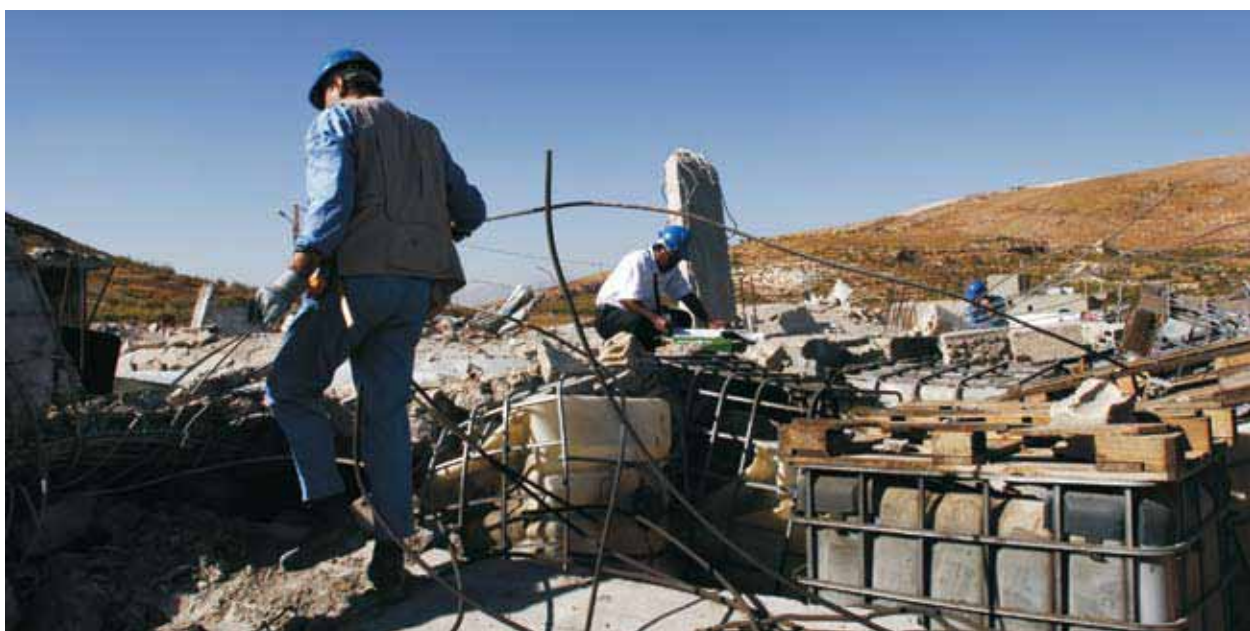
UNEP inspects the damaged structure of the textile factory

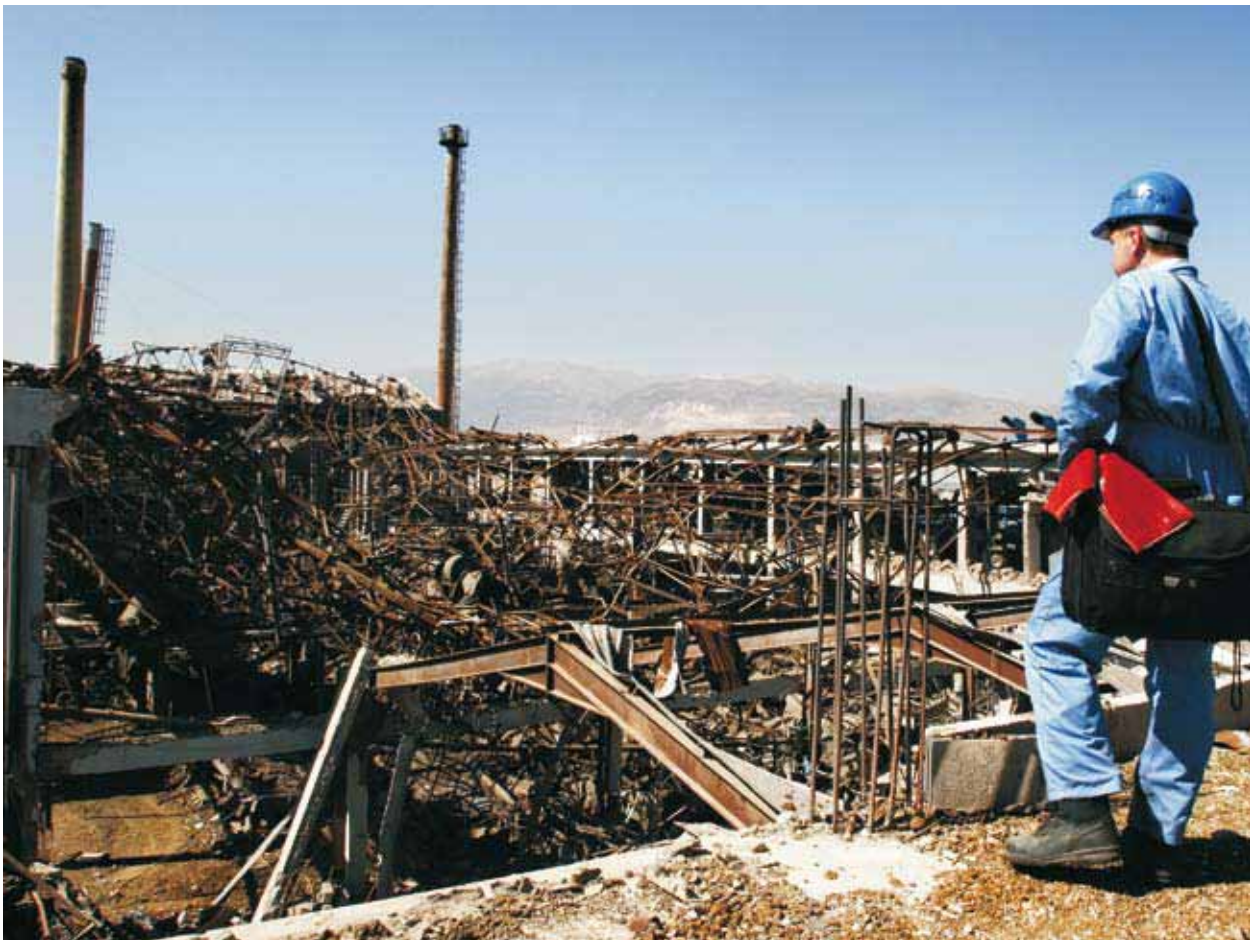
Sodium carbonate is not toxic as such, but reacts with water to form a strong alkaline solution. Hence, the substantial amount of salts stored at the site constitutes a potential hazard for groundwater, particularly during heavy rainfall when much of this material could be mobilized.

*A view of the destroyed glass factory, with remaining chimney stacks in the background*

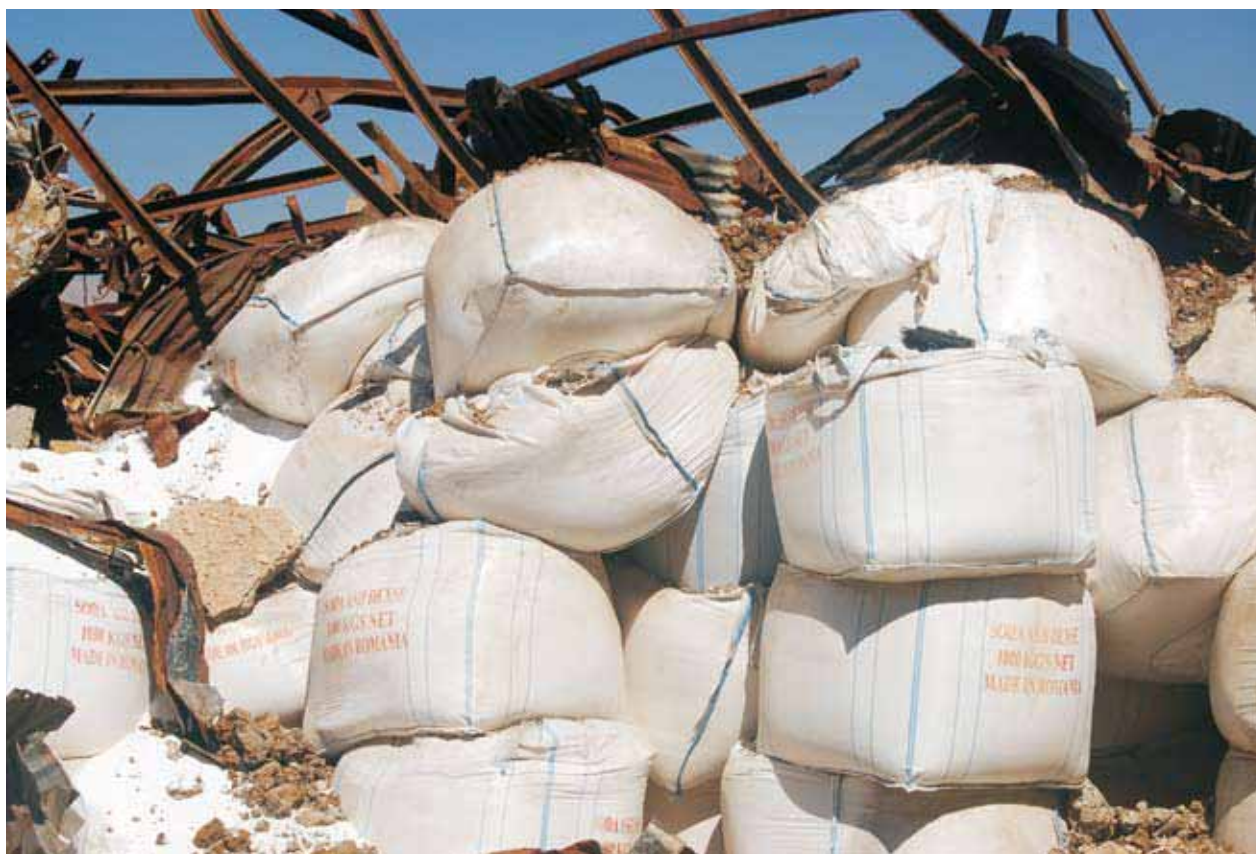
Chemicals used in glass production will leach into the groundwater unless relocated under cover

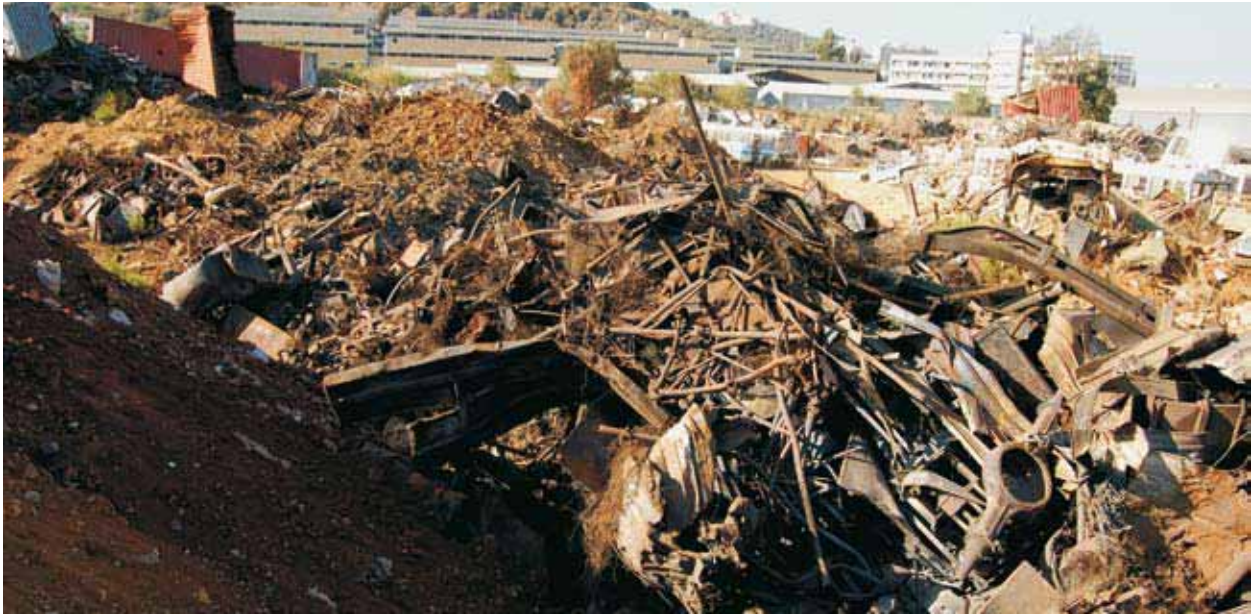
*Demolition waste at Lamartine Food Industry requires disposal*

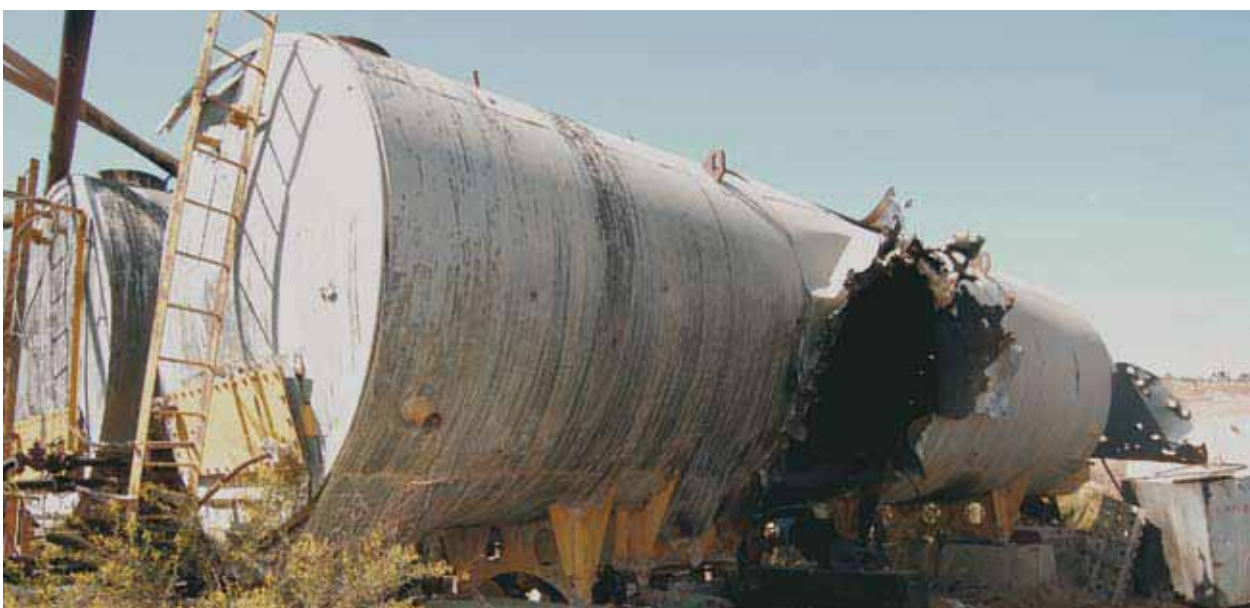
All samples showed signs of diesel contamination, and two (nos. 01 and 02) showed signs of asphalt contamination.

*A damaged diesel tank in the Ebl Saqi asphalt plant*

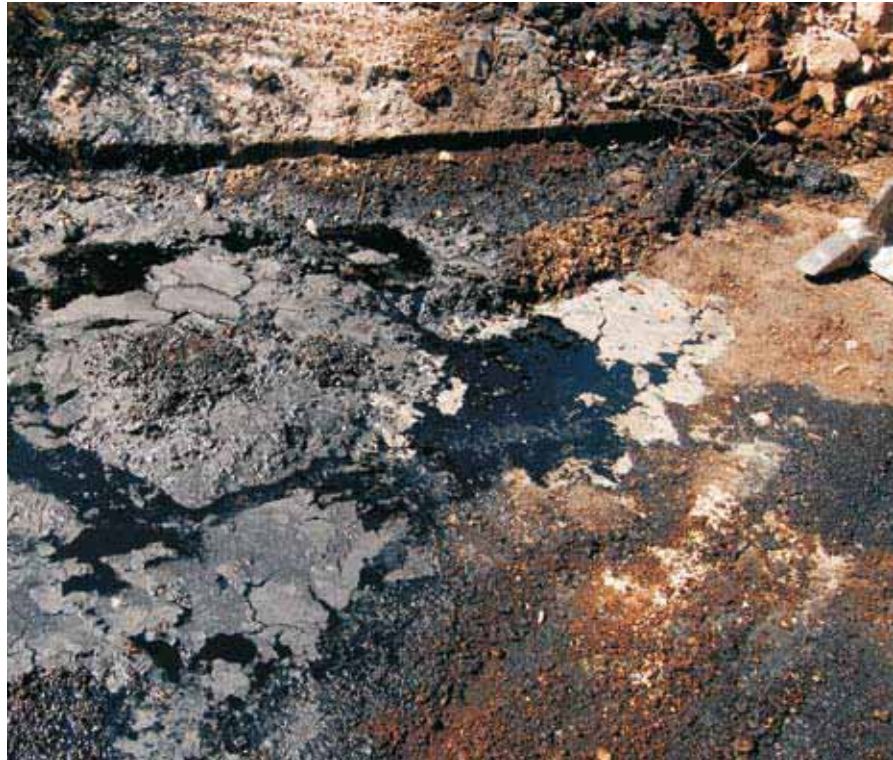
Solid waste was observed to be present on site in the form of hydrocarbon contaminated soil and scrap metal from the damaged tank.

*A pool of diesel and asphalt in the vicinity of the damaged tanks*

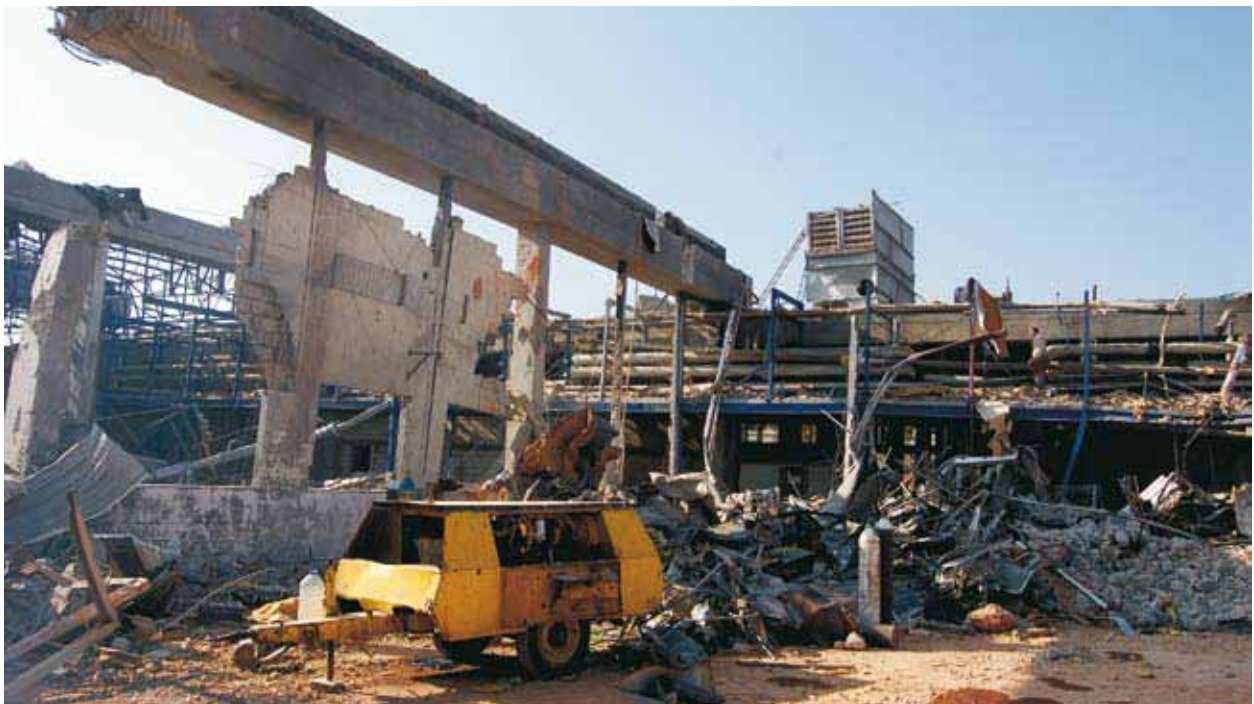
*A view of the destroyed Liban Lait dairy complex*

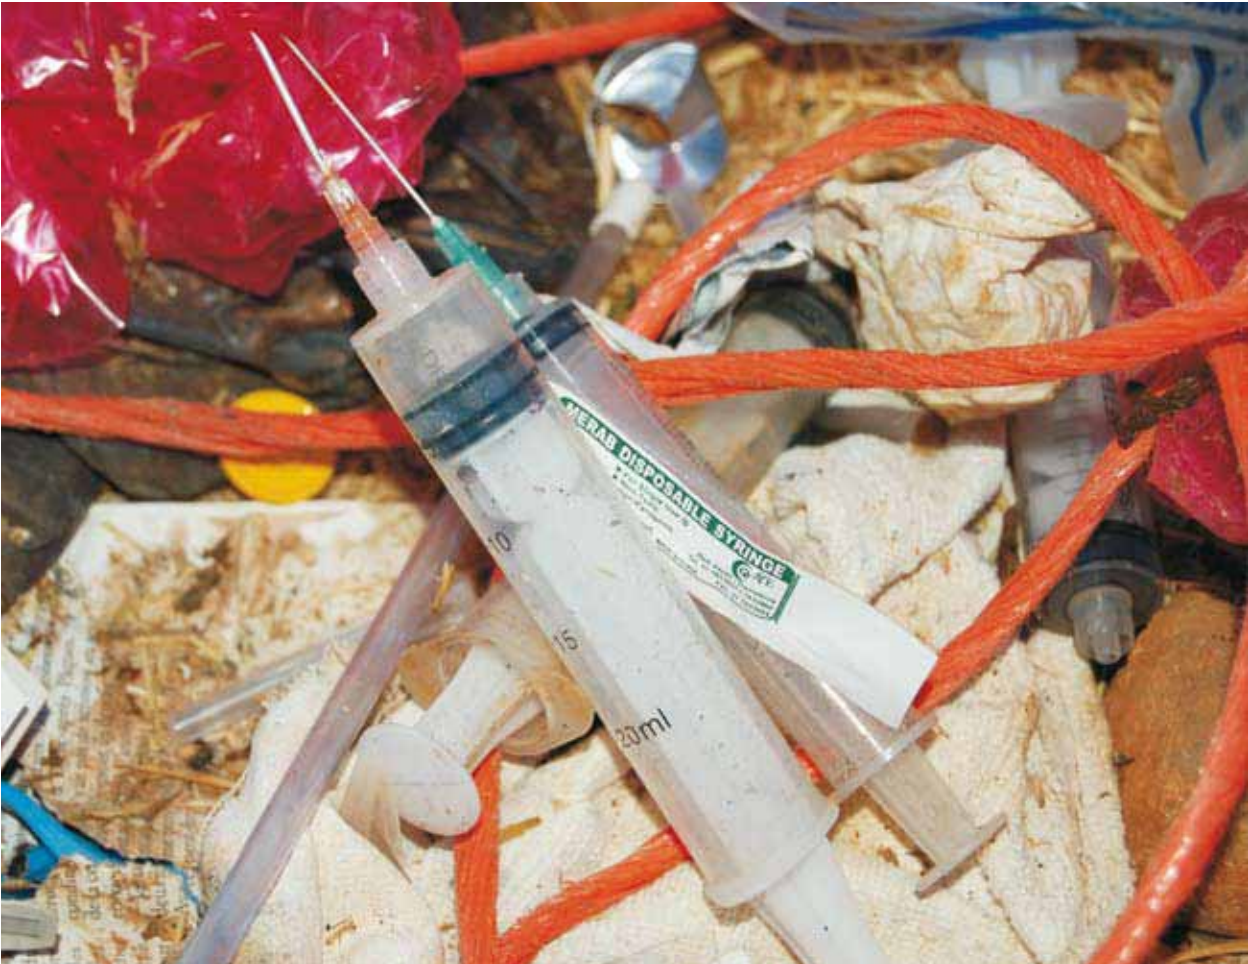
*HHCW from the dairy plant at the local dump site. Such items represent a serious risk for the health and safety of local residents*

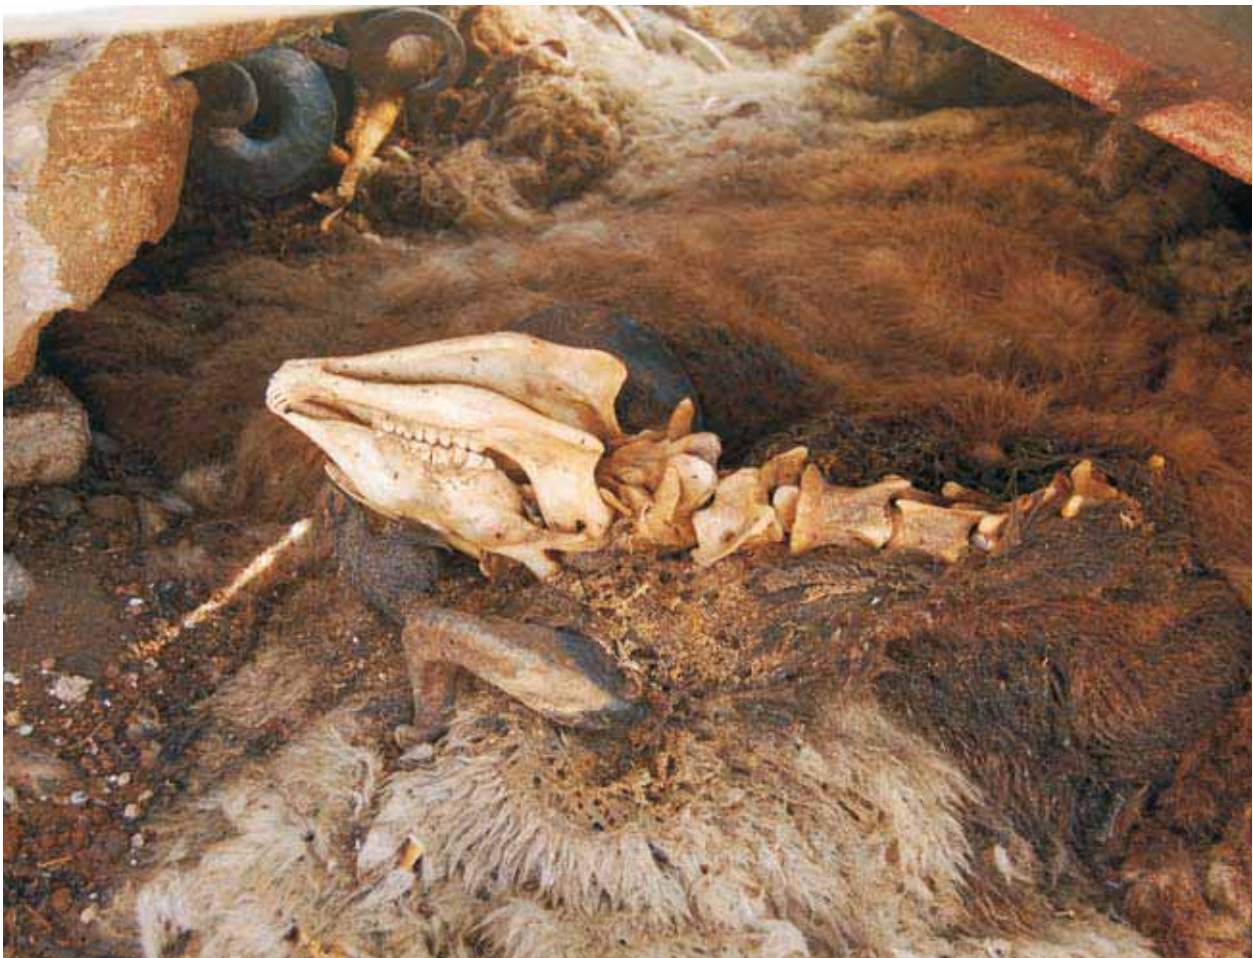
*Piles of rotting animal carcasses across the site are contaminating surface water and present a risk for public health*

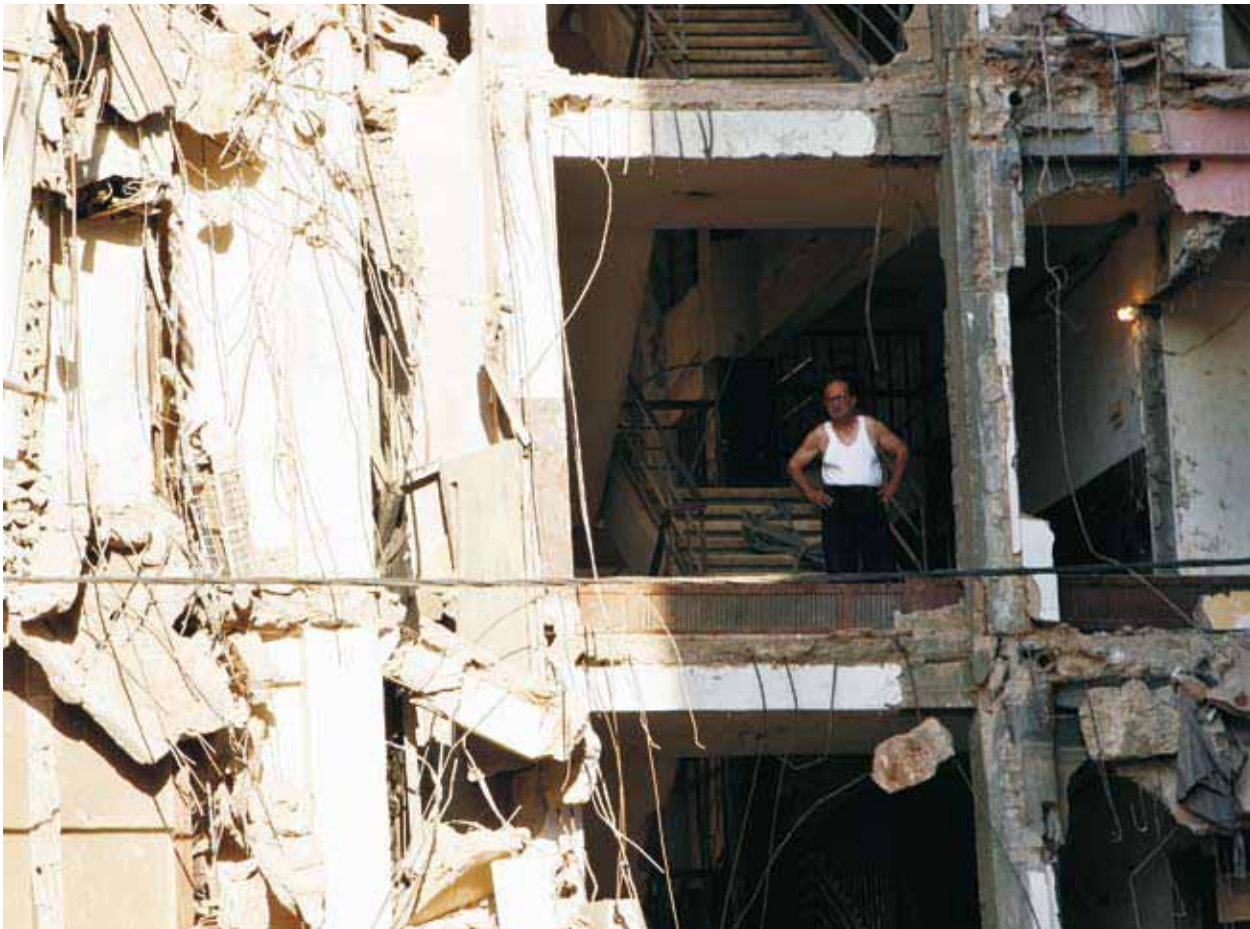
*A severely damaged building in the southern suburbs of Beirut*

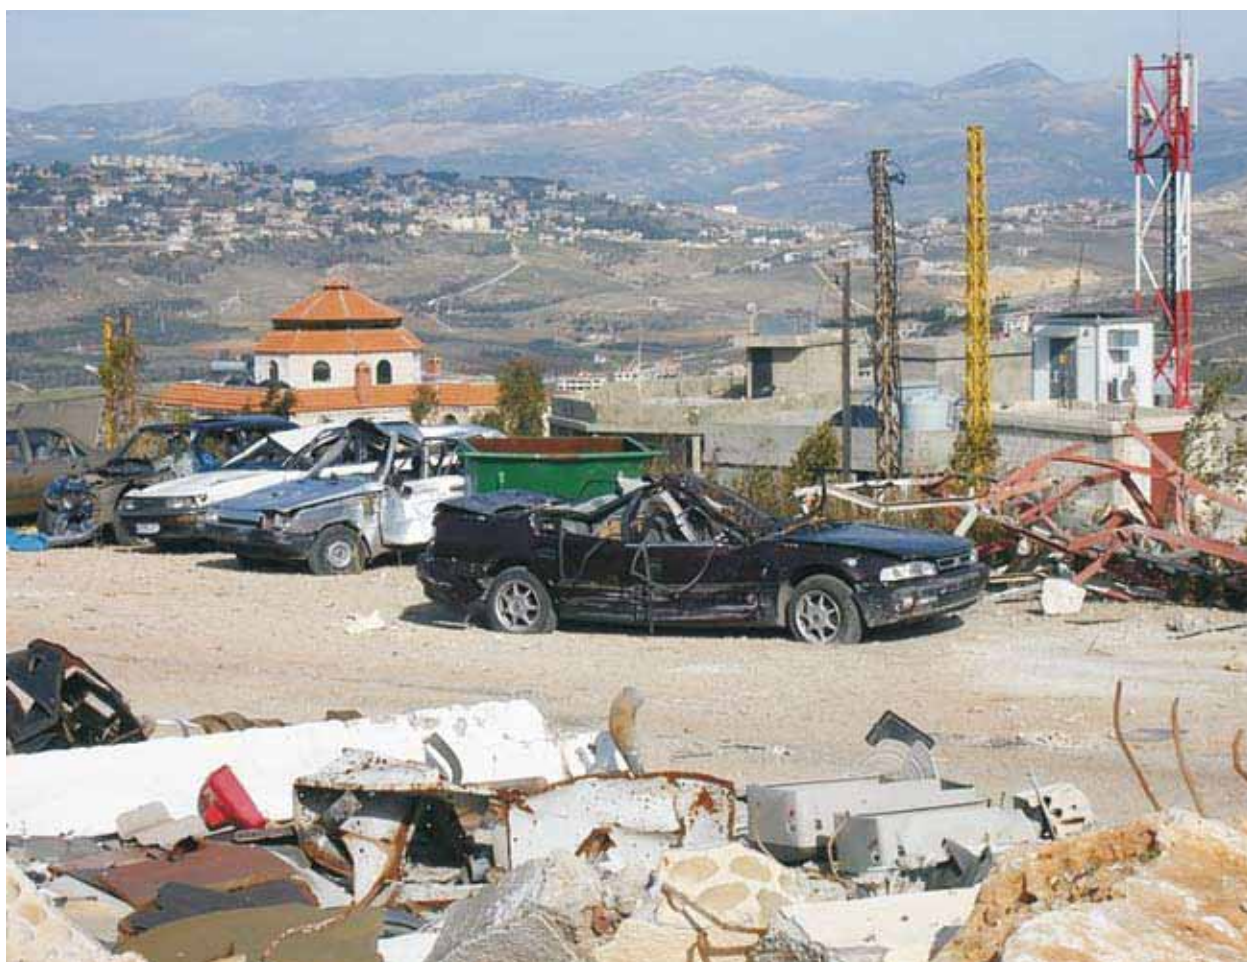
*Burnt car batteries are likely to be the source of elevated lead concentrations at the site of the former Khiam prison*

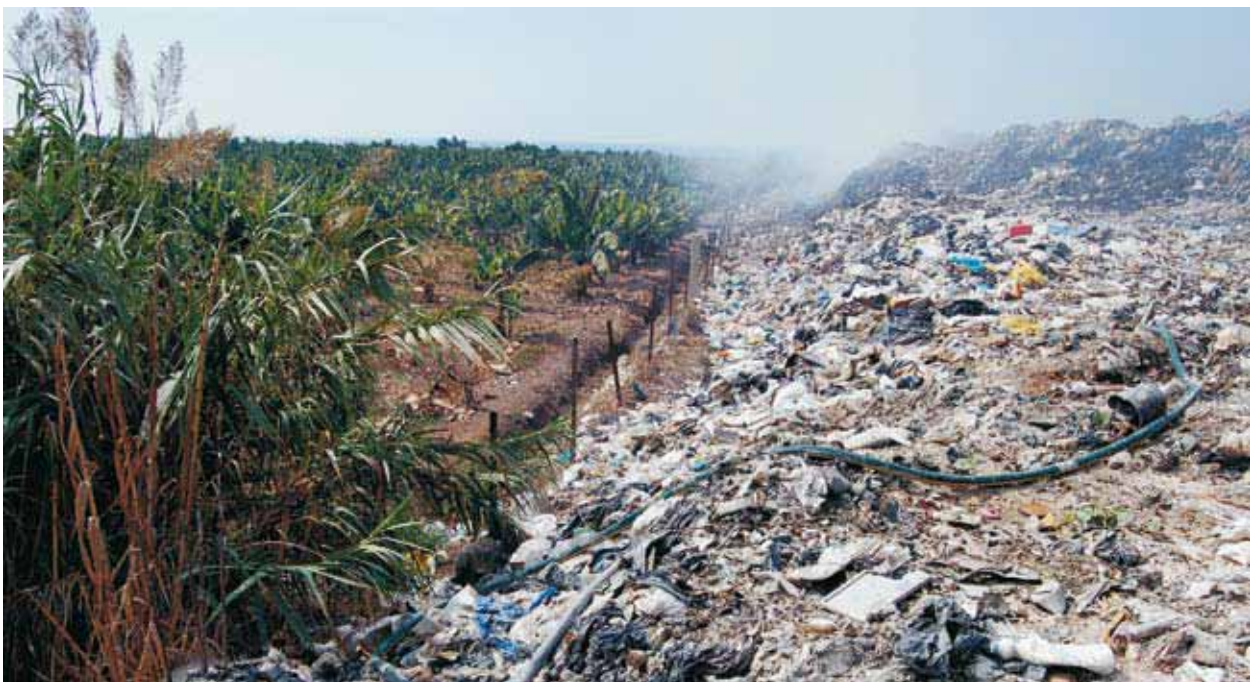
*A view of the Tyre dump site, which is a source of dust, smoke, odours and disease vectors*

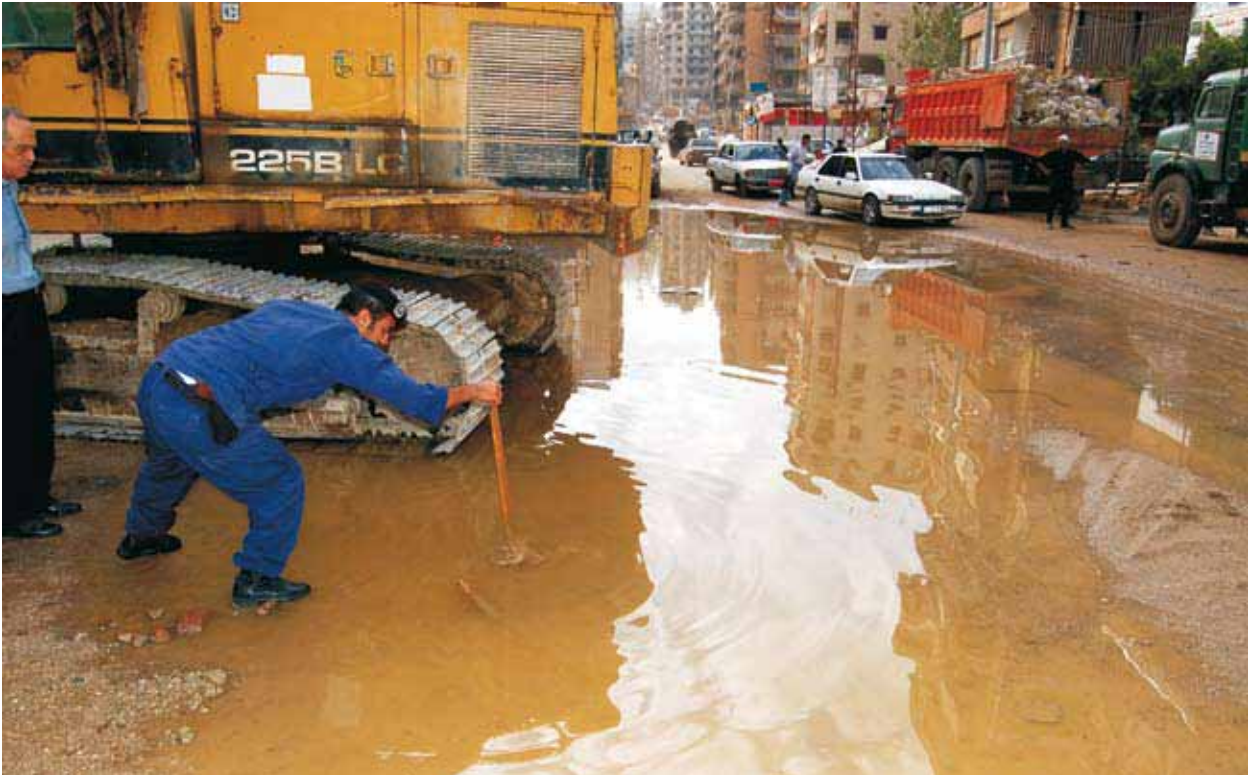
*Stagnant water pools from damaged water mains in Haret Hreik*

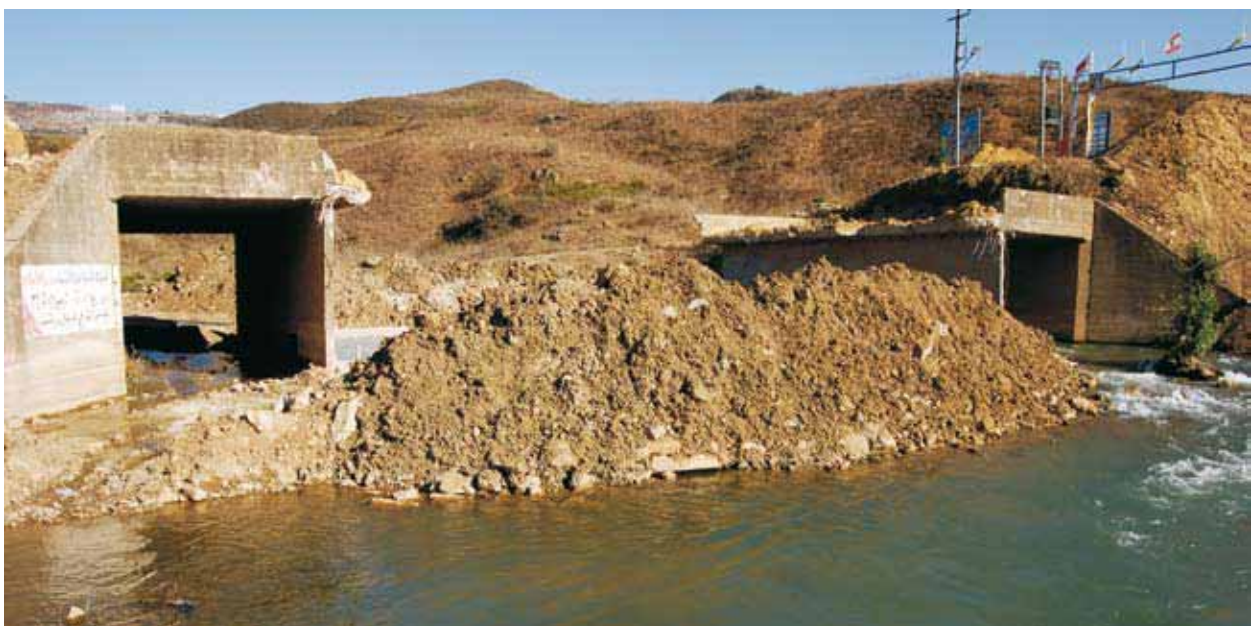
*Debris from destroyed bridges, such as this one on the Litani River, could lead to flooding in the rainy season*
