# Lebanon

## Post-Conflict Environmental Assessment

United Nations Environment Programme

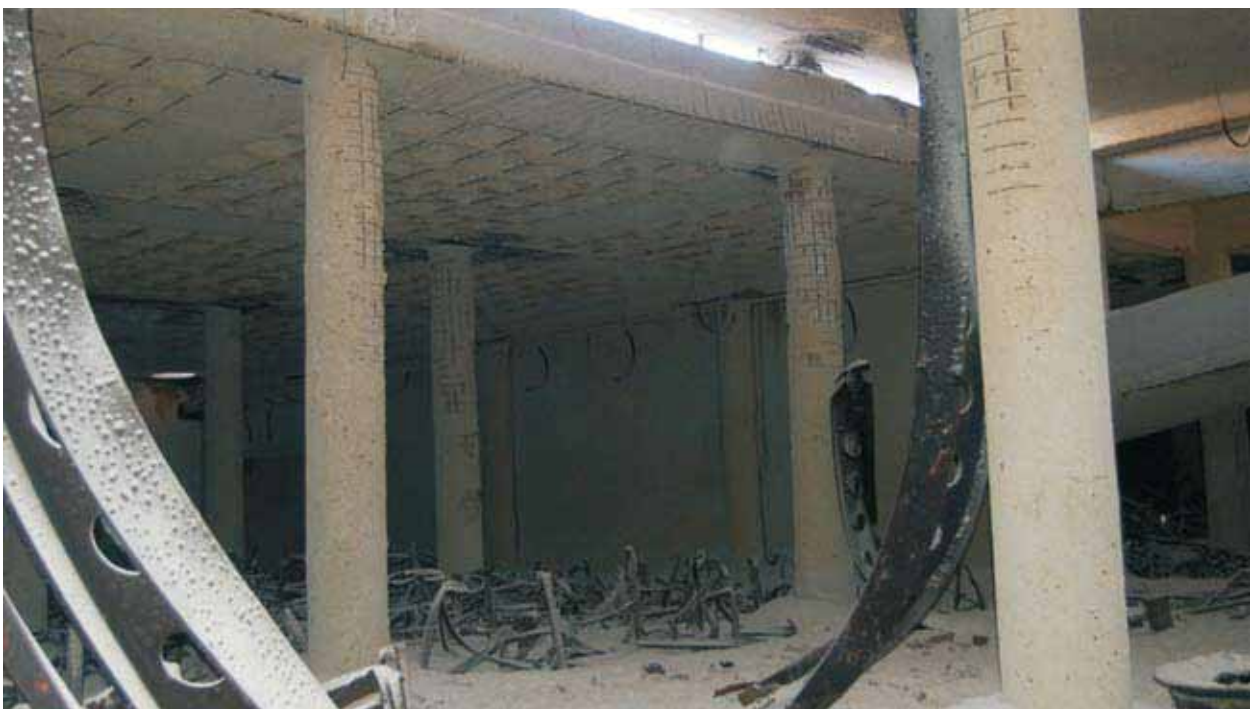
*The Transmed Industry in Beirut shows typical damage from the impact of a 'bunker buster' bomb*

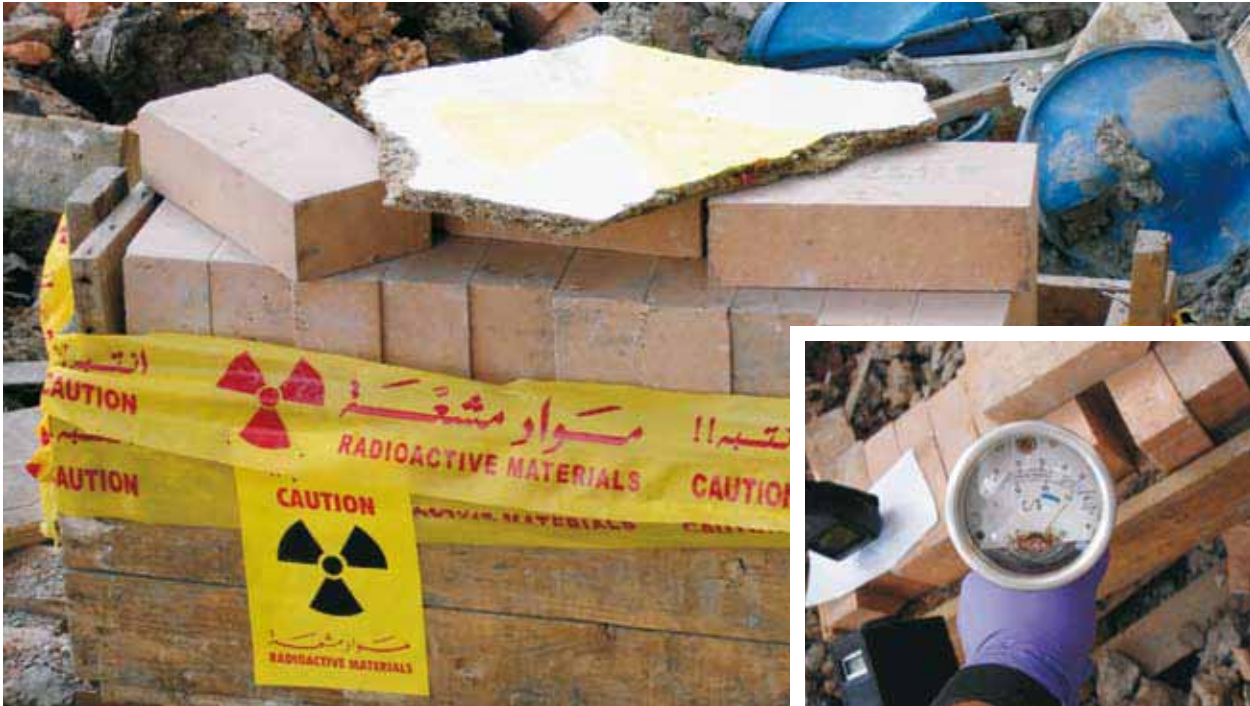
*High-temperature oven bricks showing elevated radioactivity readings*

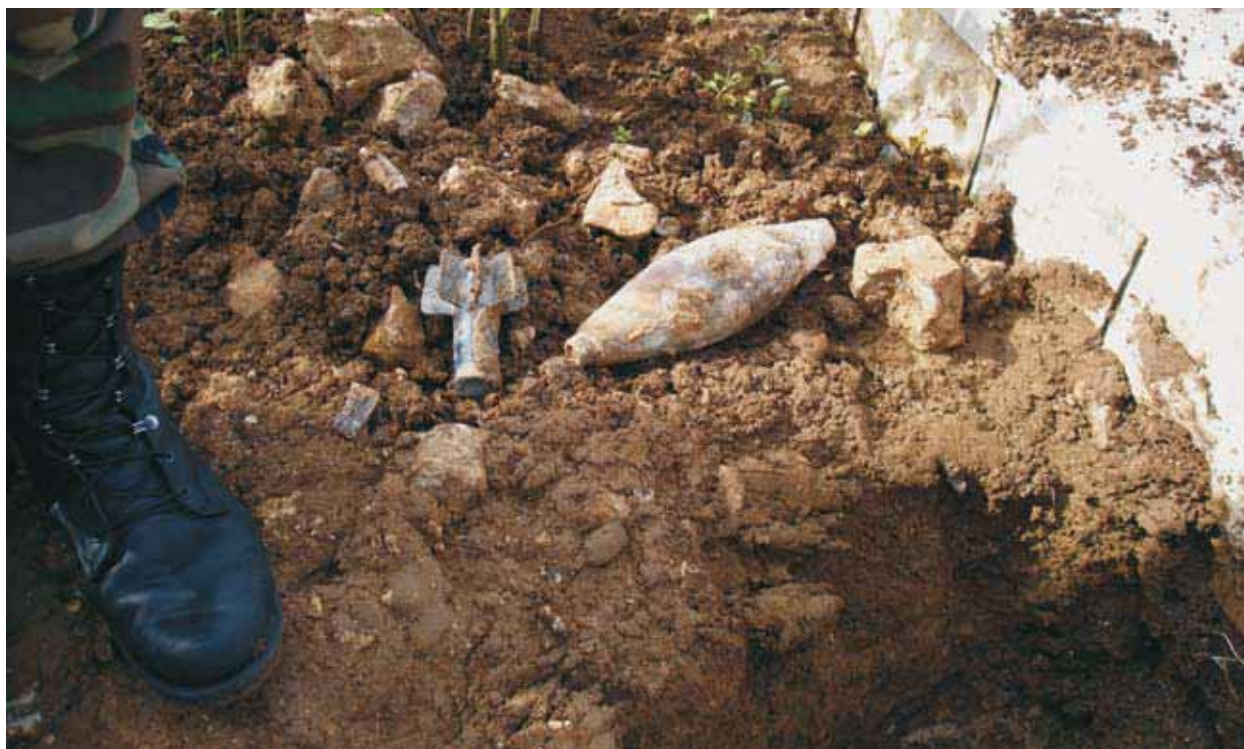
*A white phosphorus mortar shell was found by UNEP at Deir Mimas*
