Assessment of Contaminated Soil and Groundwater

4.1 Field observations of the current situation on land

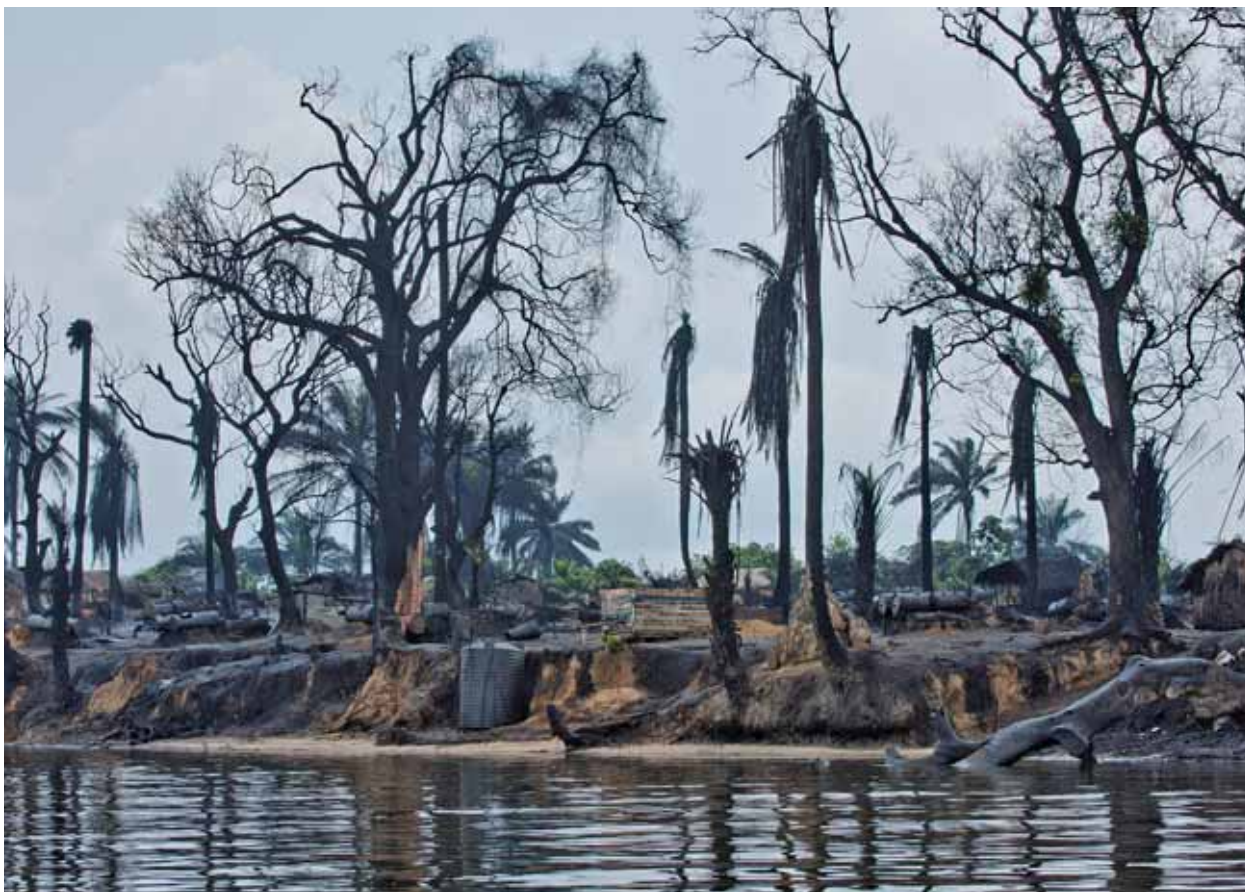
massive fire was raging at the Yorla 13 oil well and apparently continued burning for over a month. Such fires cause damage to the vegetation immediately around the well site and can produce partly burned hydrocarbons that may be carried for considerable distances before falling on farmland or housing.

An oil well on fire (Yorla 13, Khana LGA)

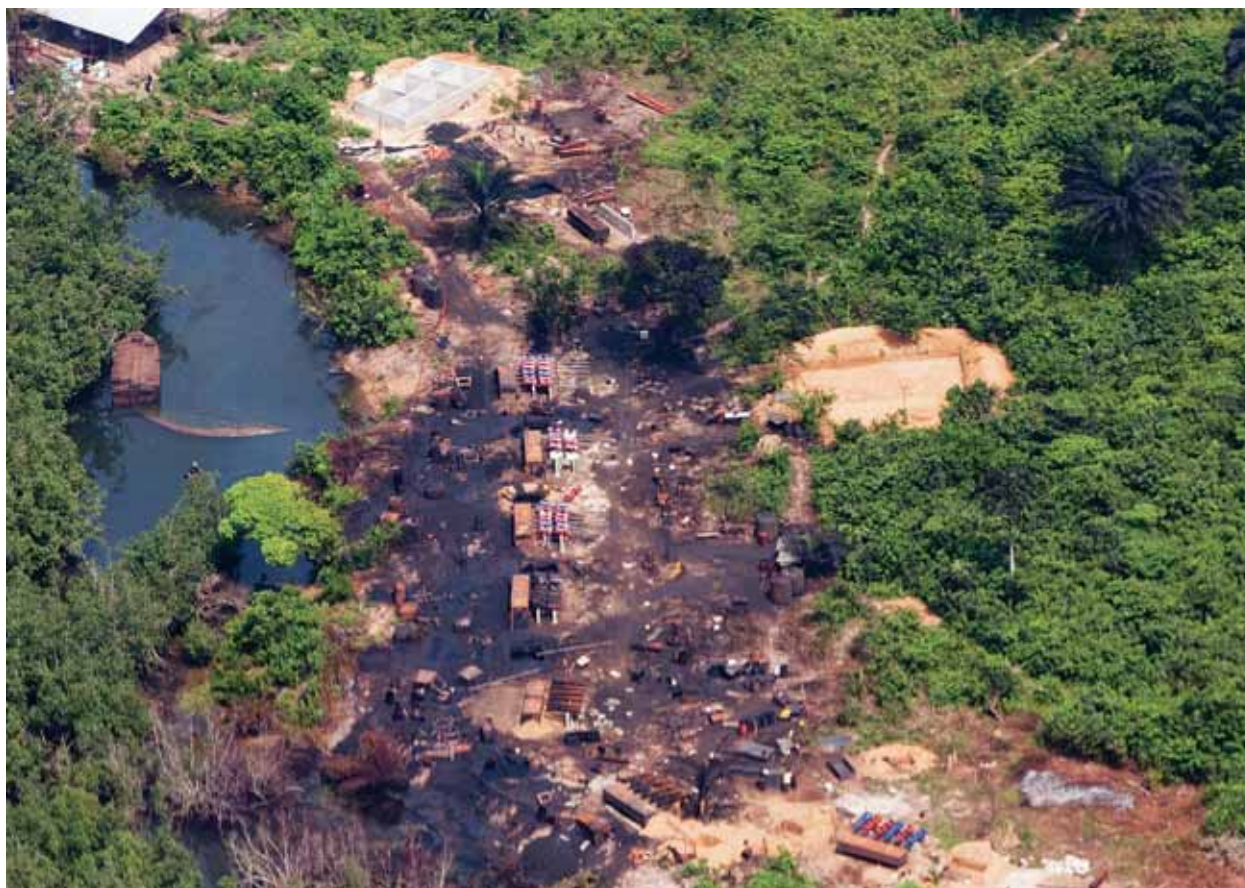
Aerial view of artisanal refining site (Bodo West, Bonny LGA)

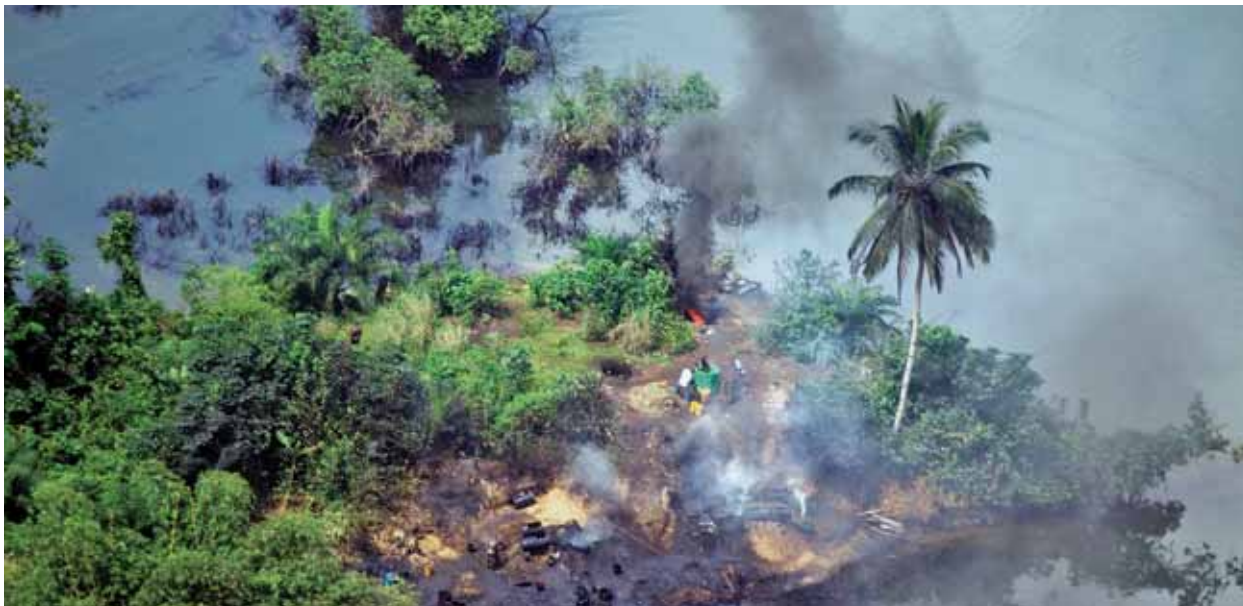
Aerial view of a typical artisanal refining site in operation (Bodo West, Bonny LGA)

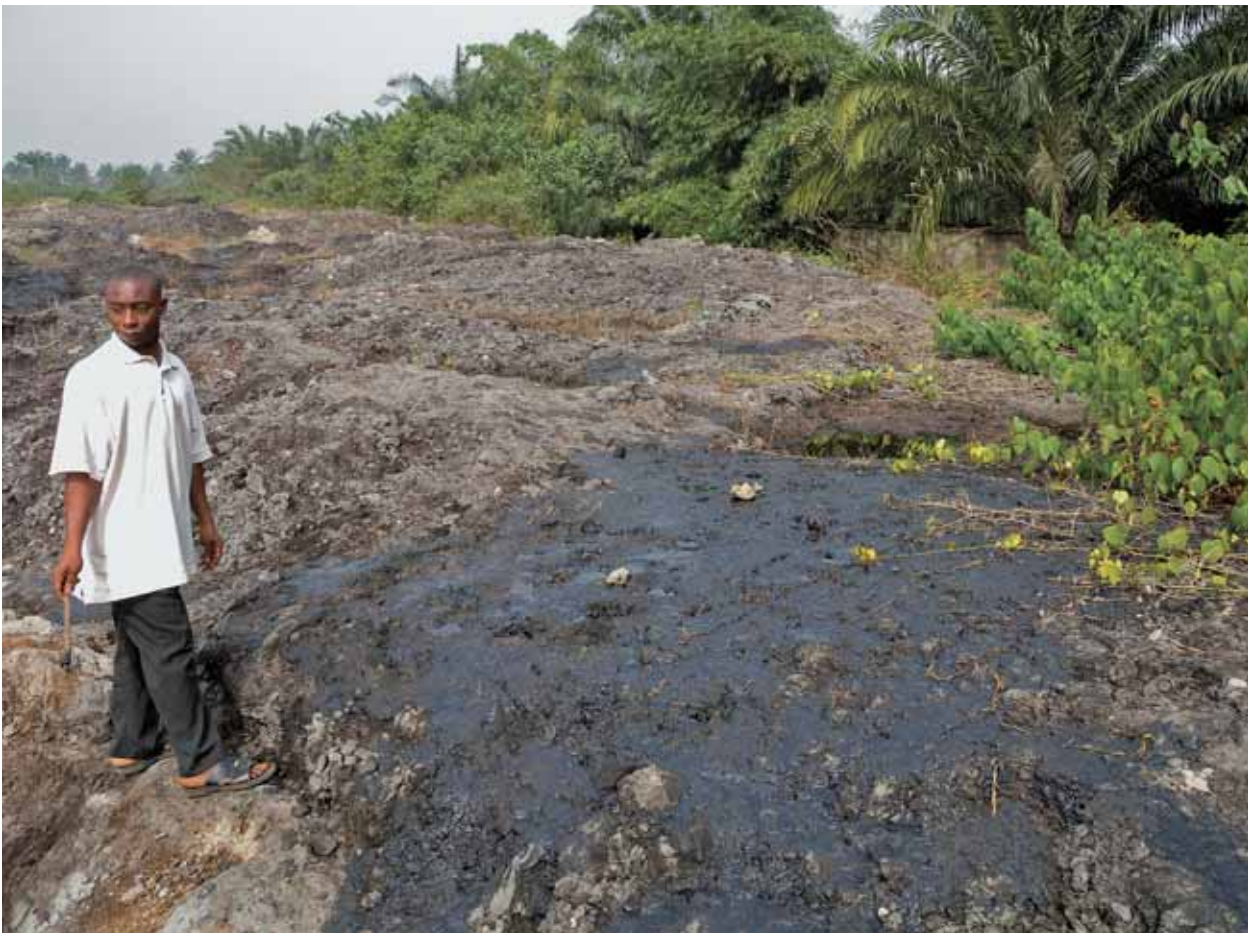
Spill and remediation history. During the Biafran War in 1970, the now abandoned Rumuekpe manifold to Bomu manifold trunk line was damaged. Crude oil spilled flowed downwards in an easterly direction into a lagoon approximately 200 metres east of the pipeline. From the lagoon the oil washed further into creeks, leading to contamination of downstream areas. Part of the area caught fire, evidenced by crusts of ash and tar or bitumen over the main contaminated area.

Community guide at Ejama-Ebubu, Eleme LGA

Conclusions. Although the spill is over 40 years old and repeated clean-up attempts have been made, contamination is still present at the site. The observed levels of contamination are higher than Nigerian Government

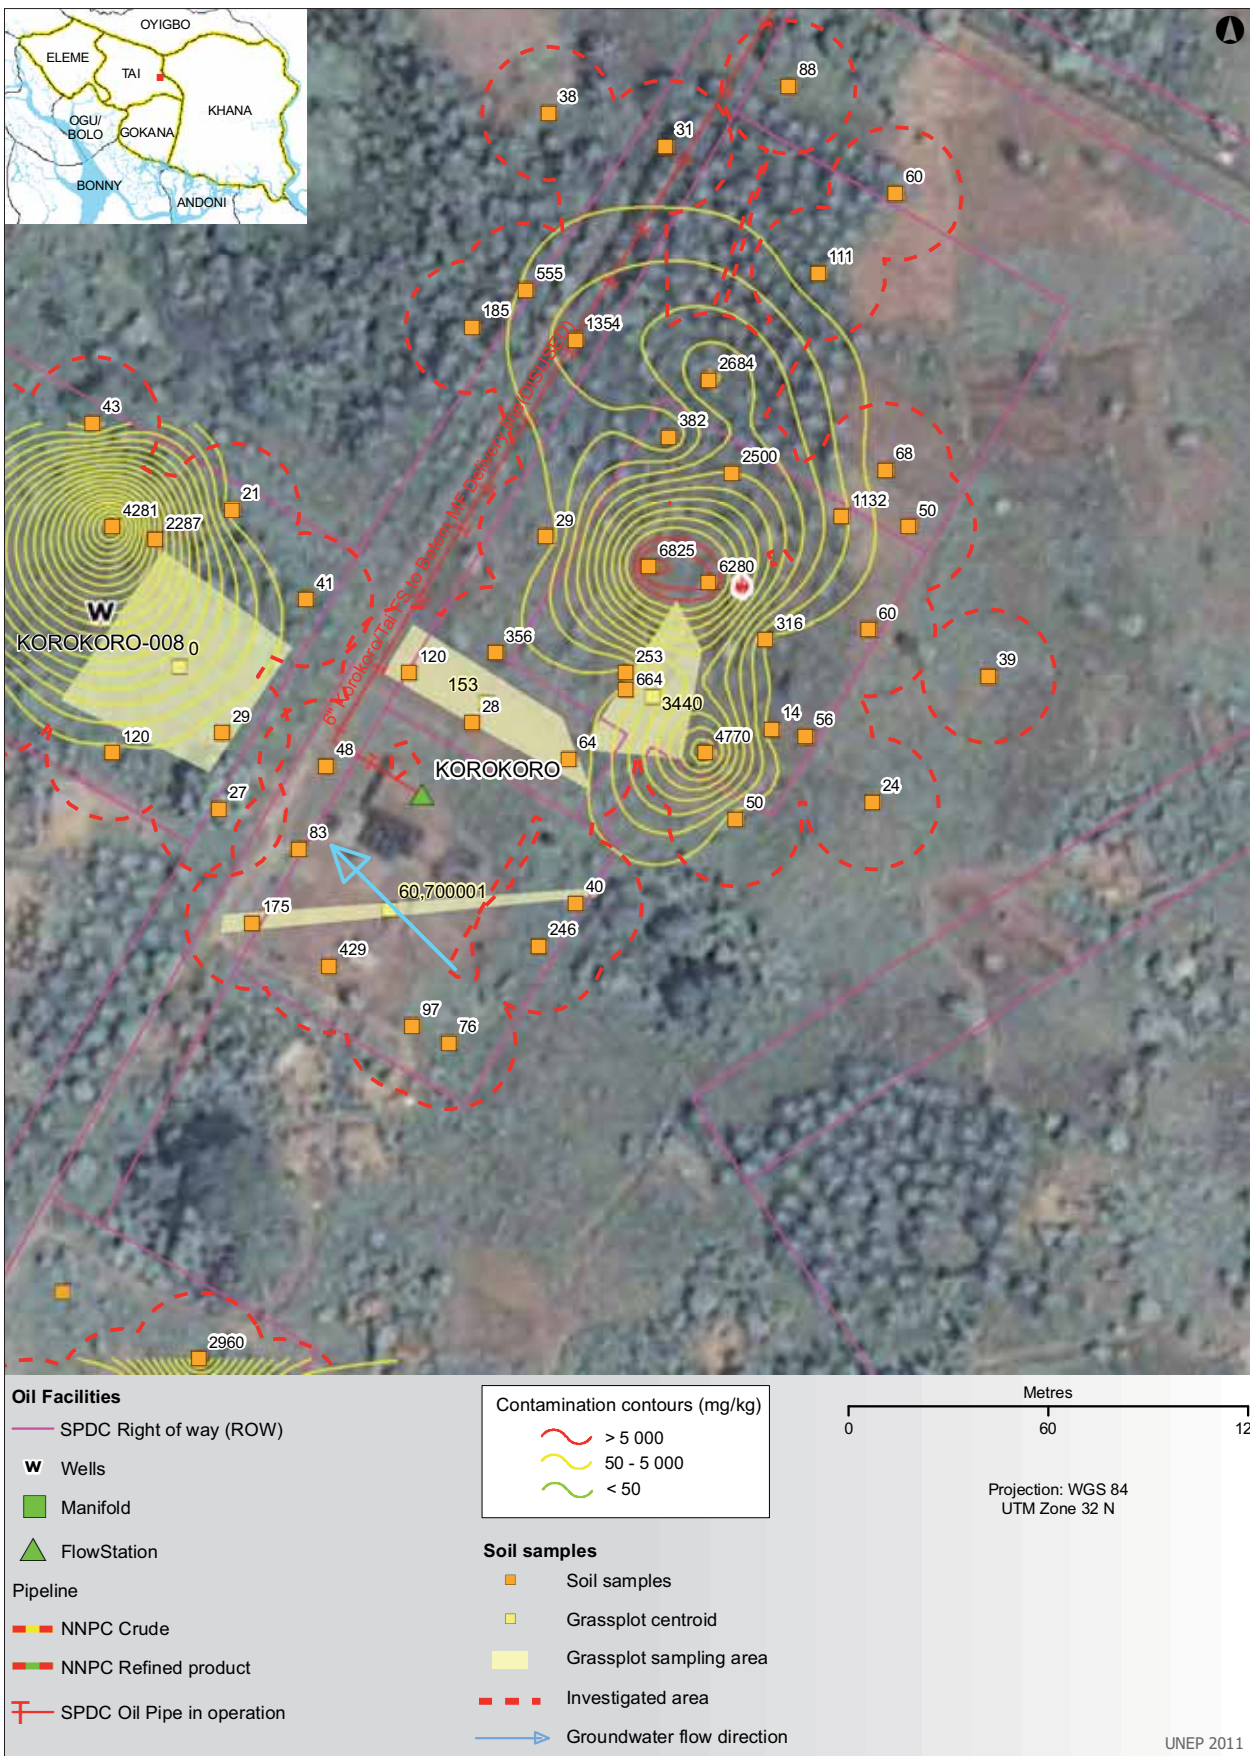
Map 13. Contamination contours at Korokoro Well 8, Tai LGA

UNEP site code	qc_008-001
Site name	Korokoro flow station
LGA	Tai
Site description	SPDC legacy site
Investigated area (m ²)	41,052
Number of soil samples	204
Number of groundwater samples	4
Number of drinking water samples	4
Deepest investigation (m)	5.20
Maximum soil TPH (mg/kg)	14,200
Number of soil measurements greater than EGASPIN intervention value	13
Deepest sample greater than EGASPIN intervention value (m)	5.00
Maximum water TPH (µg/l)	769
Number of water measurements greater than EGASPIN intervention value	2
Presence of hydrocarbons in drinking water	no
Number of soil measurements below 1 m	171
Number of soil measurements below 1 m greater than EGASPIN intervention value	12
Total volume of soil above intervention value (m ³)	3,390
Total volume of soil above target value (m ³)	48,501

Given human smell detection levels for petroleum hydrocarbons of between 200 and 500 mg/kg, the average human being would probably not notice the contamination in the top 1 metre of soil around the B600 sampling location.

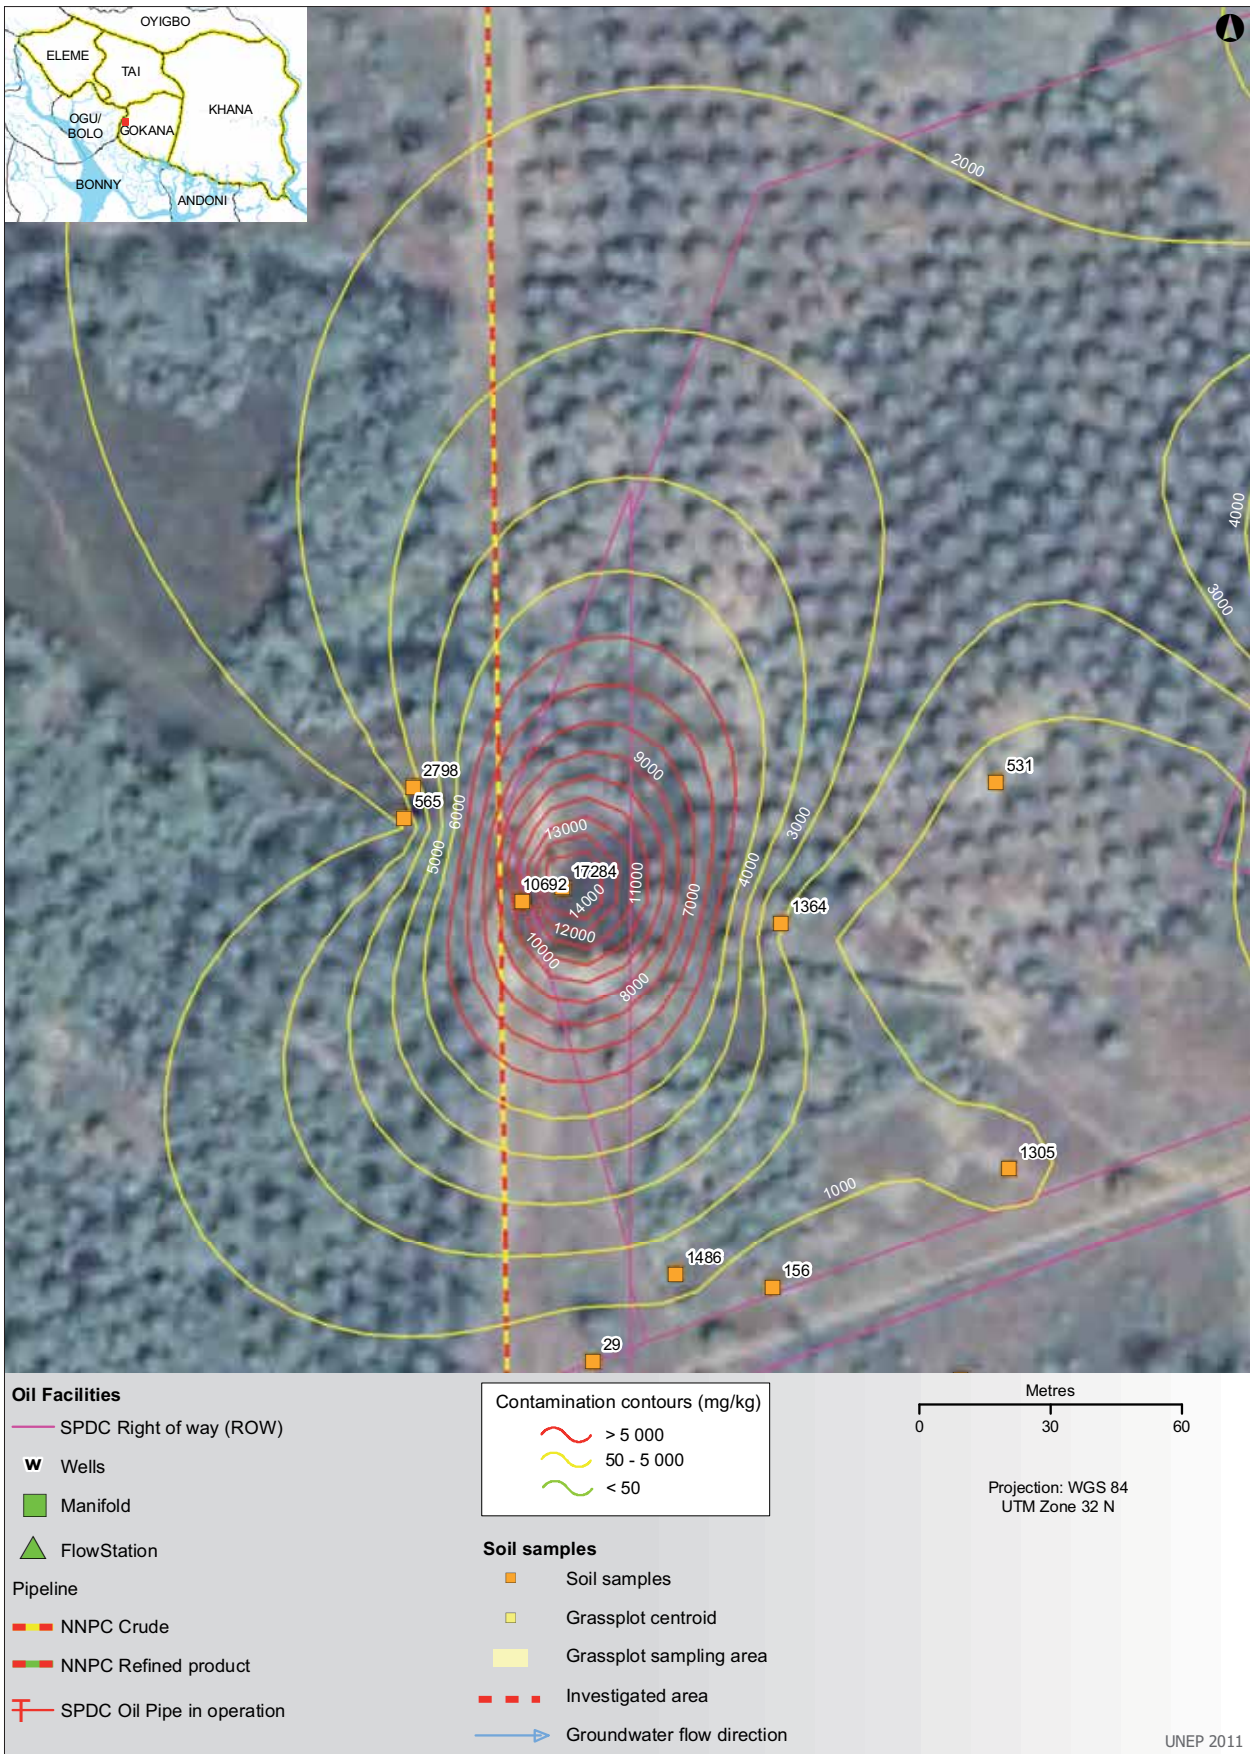
Map 14. Contamination contours at NNPC spill, K-Dere Gokana LGA

The sediment sample 019-011-SED-5000, taken from the creek, proved to be highly contaminated, laboratory results showing TPH at 32,600 mg/kg. The gas chromatography (GC) fingerprint of the oil at a depth of 2-3 metres was identical with that found in the sediment from the creek, proving the linkage between source and impact (Figure 11a and 11b). The hydraulic connection between contaminated land and creeks will have important implications for the sequence of remediation to be carried out. Until the land-based contamination has been dealt with, it will be futile to begin clean-up of the creek as pollutants will continue to migrate towards the creek, re-contaminating water, sediments and vegetation.

General conclusions. Soil contamination arising from the 1990 NNPC pipeline blowout impacted an extensive area. No effective remediation has taken place at either site, such that an area of approximately 5,000 square metres has been impacted and is devoid of any vegetation. Soil contamination extends to a depth of at least 5 metres.

The soil in the core affected area must be considered highly contaminated, based on the concentrations of hydrocarbons, and is currently unfit for any further use. The absence of any protective vegetation has led to soil erosion and heavy contamination – via transport and deposition of contaminated particles – of the adjacent creek and possibly the surrounding agricultural land. Direct runoff of oil for the duration of the rupture, and subsequent sub-surface transfer of contamination, also cannot be ruled out. Since the waters in the creek are tidal, the hydrocarbon coating of the sediment grains will be washed off or dissolved, or the sediment itself may be transported, leading to further downstream contamination.

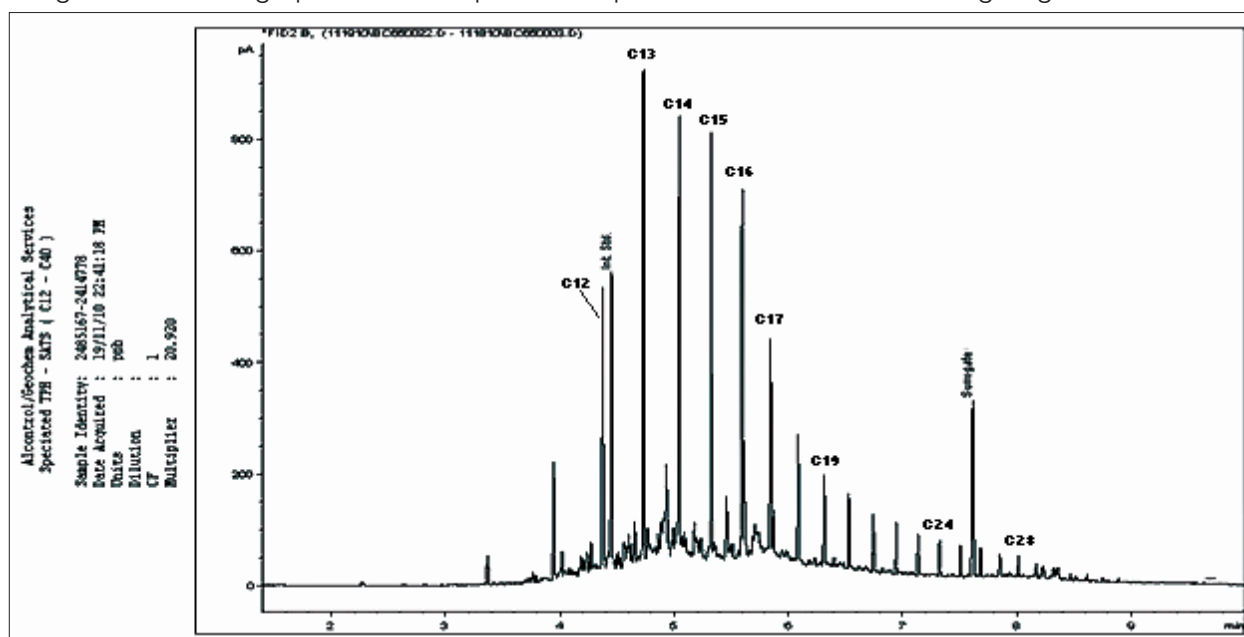
Figure 12. GC fingerprint of the oil phase sample 001-022-X-100 from a Big Bag

Gas chromatograph-flame ionization detector (GC-FID) fingerprints of the aliphatics fraction (C12-C40, see Figure 12) revealed that the oil was a fresh and unweathered crude oil. An analogous series of n-alkanes are clearly visible, indicating relatively fresh oil. Below this a small unresolved complex mixture can be seen, indicating the presence of some weathered material.

General conclusions. Examination of the site and subsequent laboratory analysis revealed the likely source of the material to be cuttings from oil drilling operations. It falls to the responsible authorities to monitor the movements of hazardous waste from source to end point under a duty of care. The fact that waste of this type is being disposed of in an open and unlined pit proves that the chain of custody between waste generator, waste transporter and waste disposal facility in the region is not being adhered to. The local environmental authority, lacking a proactive support network, is obviously not in a position to monitor instances like this. The case also demonstrates a lack of control by the operator of the site from where the material originated.

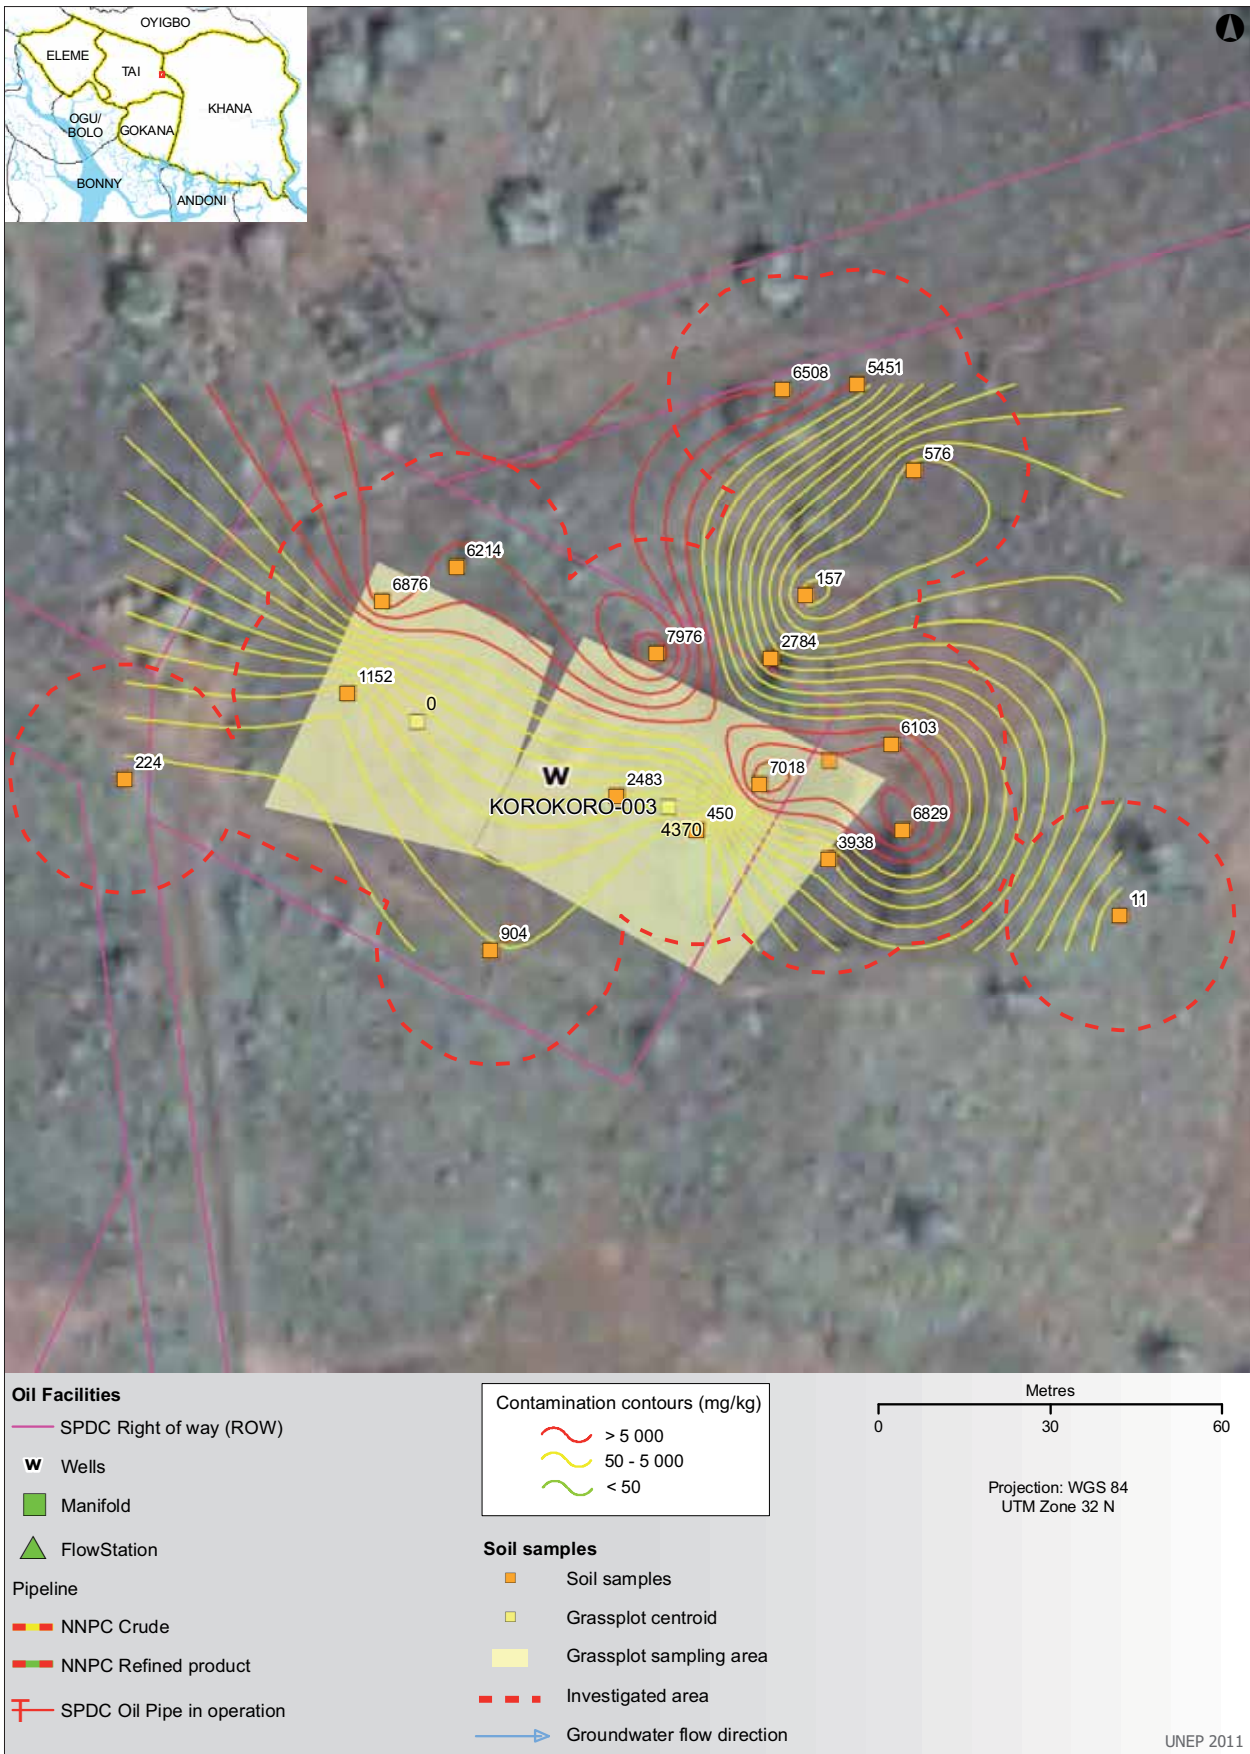
Map 16. Contamination contours at Korokoro Well 3, Tai LGA

Sampling station	Depth from (m)	Depth to (m)	TPH (mg/kg)
008-002-S01-B210	0	0.4	10,600
	0.4	1.0	4,830
	1	1.5	6,210
	1.5	2.0	11.1
008-002-S01-B250	0	0.6	2,240
	0.6	1.0	4,300
	1.0	3.0	7,340
	3.0	4.0	5,880
008-002-S01-B350	4.0	5.0	6,890
	0	0.8	2,060
	0.8	1.5	3,260
	1.5	2.3	2,850
008-002-S01-B450	2.3	4.2	5,280
	4.2	5.0	4,310
	0	0.4	8,310
	0.4	1.2	9,050
008-002-S01-B252	1.2	2.4	10,700
	2.4	4.6	4,200
	4.6	5.0	6,120
	0	1.0	2,330
008-002-S01-B252	1.0	2.0	2,920
	2.0	3.0	6,990
	3.0	4.6	8,060
	4.6	5.0	9,510

6. A detailed plan should be prepared for (i) clean up of the contaminated soil and (ii) risk reduction at the site. Additional guidance on clean up of contaminated soil is provided in Chapter 6
7. A detailed plan should be prepared for (i) clean up of the contaminated water and (ii) risk reduction at the site. Additional guidance on clean-up of contaminated water is provided in Chapter 6
8. During the clean-up, excavation water should be carefully managed to ensure that pollutants do not escape into the environment

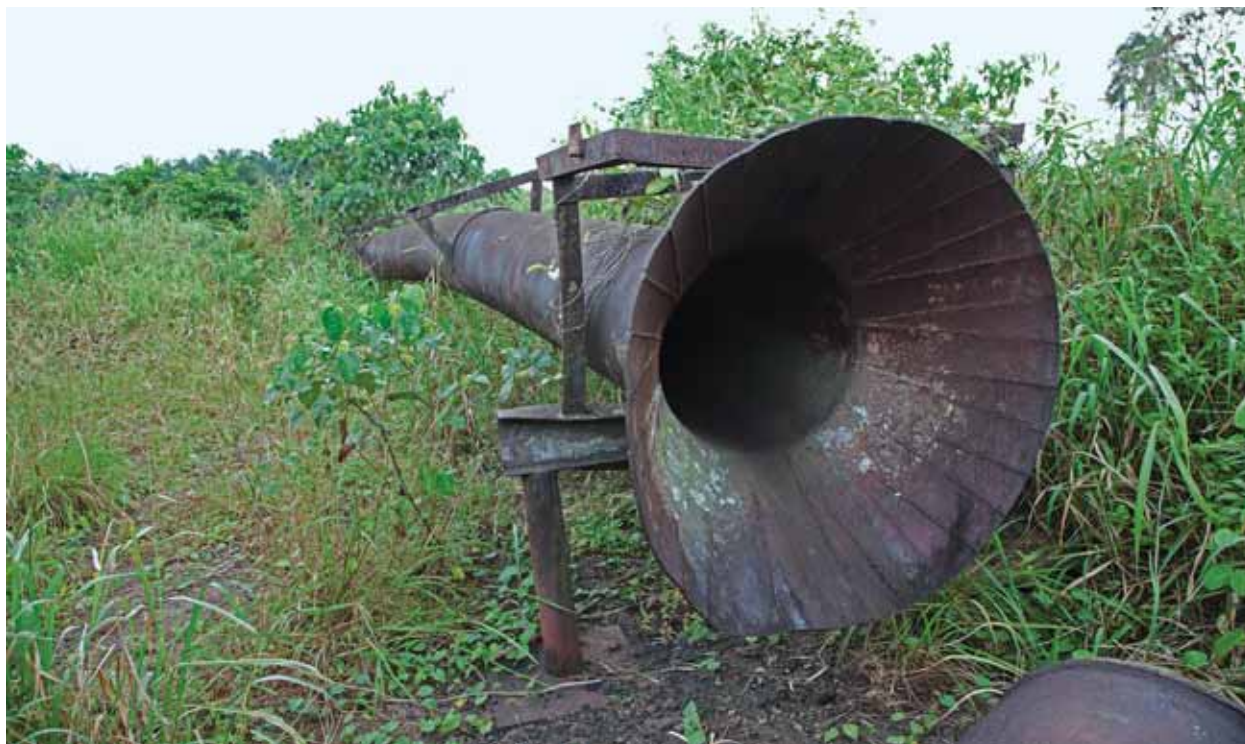
Flare arrangements at disused flow station

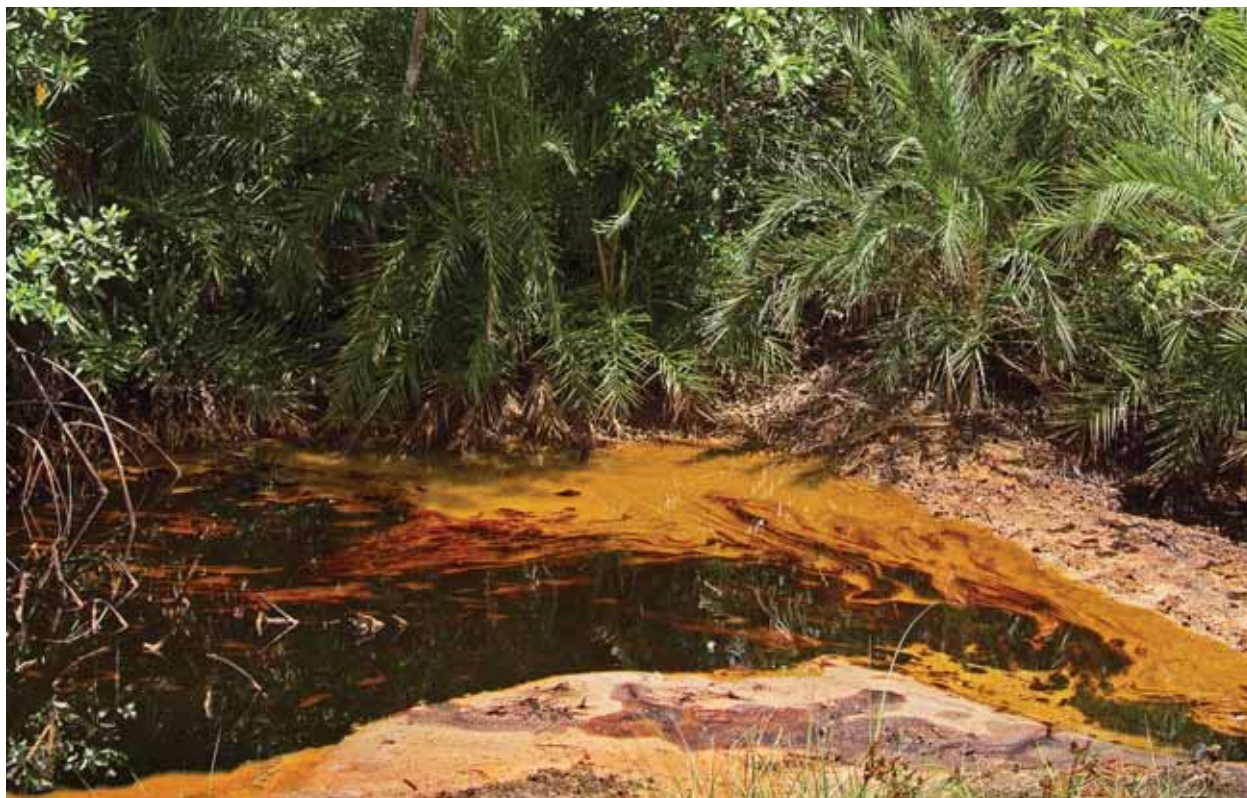
A typical spill site within Ogoniland, many of which remain unaddressed for long periods of time

Once these actions have been achieved, contamination of the site should be assessed and the clean-up process initiated.
